# CASE STUDY: DETERIORATION OF WIRE ROPES USED IN CABLE ASSIST HARVESTING SYSTEMS

Author: James Byron  
Supervisor: Rien Visser  
NDT Inspector: Bertus Marks  
With thanks to Hancock Forest Management

University of Canterbury  
October 2016

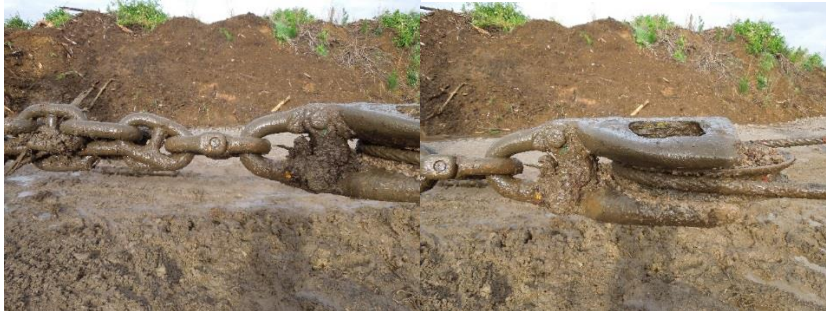
*Figure 4: Equaliser block and hammerlock system used for the rope end connection of system 3*

The ropes were more worn up to around 300m where there was fairly well lubricated 'fresh' rope between there and the drum. Trees and stumps are rarely used to change the direction of pull of the rope. The steepest felling is still being carried out manually, and it was stated that they thought they were not often over 35 degrees in slope. At the time of the test, this rope was heavily coated in mud and soil. Figure 4 shows how heavily coated in mud the rigging system and equaliser rope was.

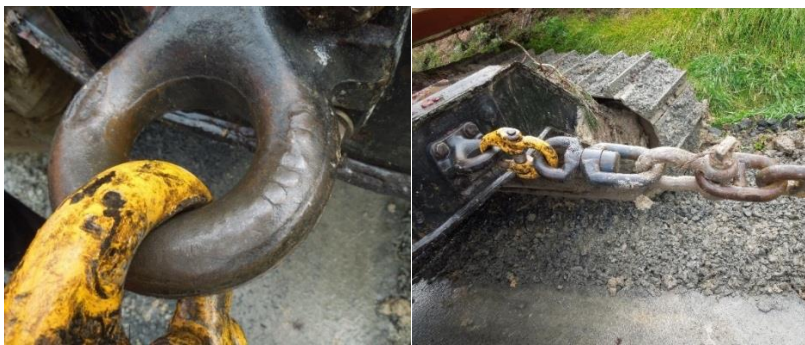
Wedged sockets were used initially to connect the rope to the felling machine, but with the difficulty of resetting them spliced eyes are now used. Some reasonable wear has also been found to be occurring between the connections with the chain to the machine. Hammerlocks are wearing reasonably heavily against shackles and both need to be replaced fairly frequently. Figures 5 shows the end connector arrangement, and Figure 6 shows some significant wear between the hammerlock and the felling machine in this system.

*Figure 6: Example of wear between hammerlock and towing eye, and its attachment to the chain on system 4*

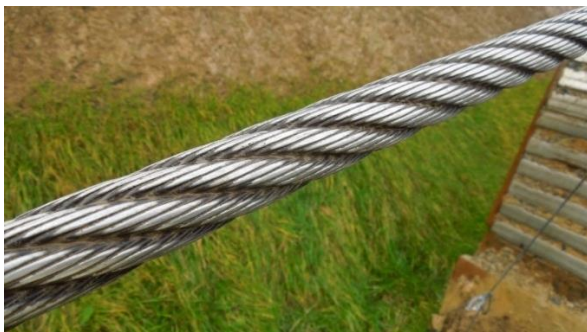
The rope as tested was in good condition, it appeared new even though it had a reasonable number of hours on it. A length of 453m was tested, the wear was normal/medium, there was no corrosion, kinks, bending, doglegs, or mechanical damage. The NDT indicated two broken wires, one at 365m and the other at 418m. There were also some broken wires in the area of the splice, but these would be eliminated with replacement of the splice. Figure 4 shows a cleaned section of the rope at the time of the test.

*Figure 7: Cleaned section of rope from system 4. Note lack of discernible wear*

This is another example of a good condition rope. It still has relatively few hours on it at 470, and with only two wire breaks it is still in very good condition. The rope appeared to be almost new, there was no obvious discernible external wear on the rope itself.

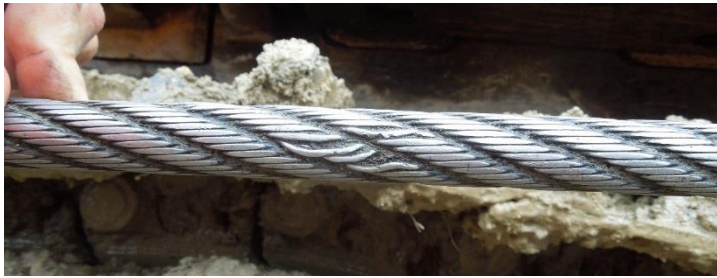
The left hand rope was in new condition, with little to no wear, no kinks, bending or doglegs. There was however an instance of mechanical damage on the rope, this was at 54m from the free end, and caused the rope to fail its inspection. The damage consisted of three broken wires in a single valley in the rope.

The damage on this rope was known by the operator before the test, and needed to be removed before the system could be used again. The damage was an accident and caused mechanically by being pinched between cleats of the dozer tracks. It was not known by the operator if the damage would be a rope failure so was not removed prior to the test. These ropes were in as new condition which would be expected having only worked 190 hours. Figure 10 shows the damage in the rope that resulted in the failure of the left hand rope.

*Figure 10: The mechanical damage resulting in failure of the LH rope in system 6*
