Case study of the state of Fish Passage in a Plantation Forest Estate and the Most Effective Ways to Fix it

University of Canterbury
2018
Georgie Holdaway
Supported by: Nelson Forests Ltd

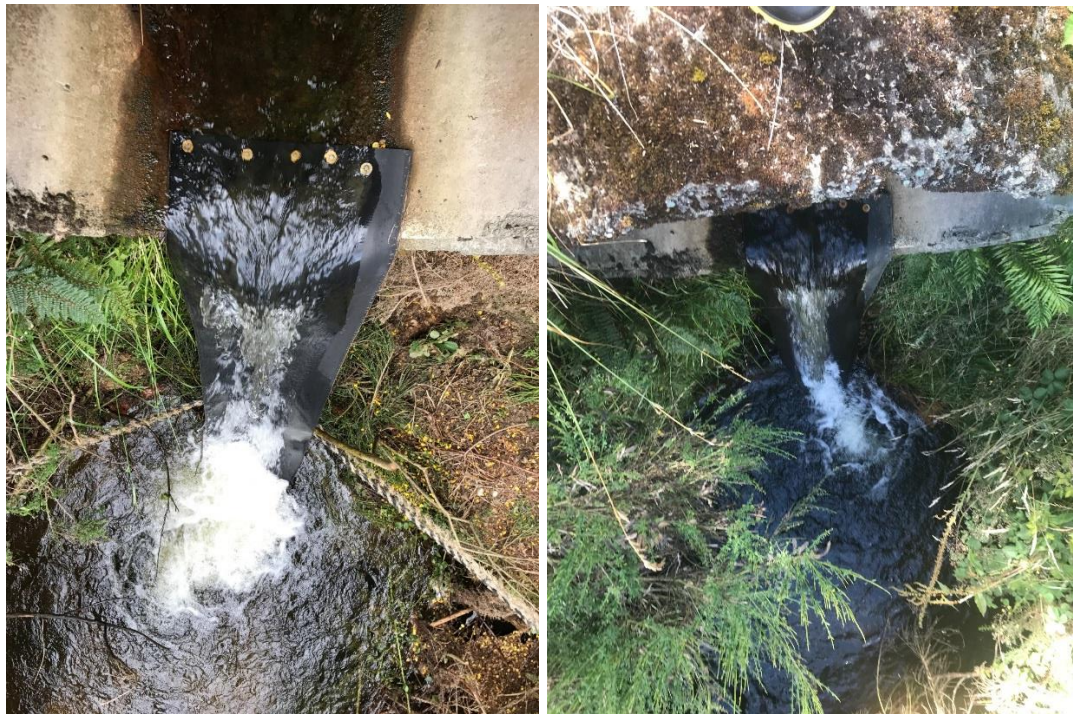
Figure 6- Aerial view of fish mat set up over a 3m perch

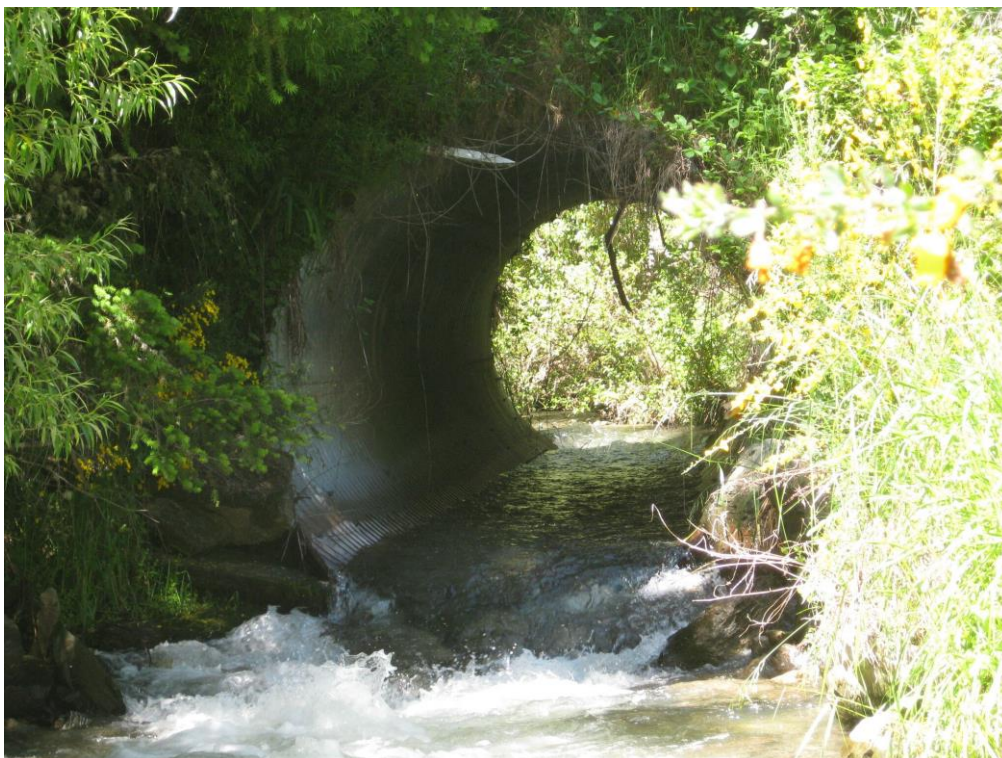
Figure 8- Large corrugated iron culvert with a medium perch, has had remediations which have washed away due to the high velocity of water.

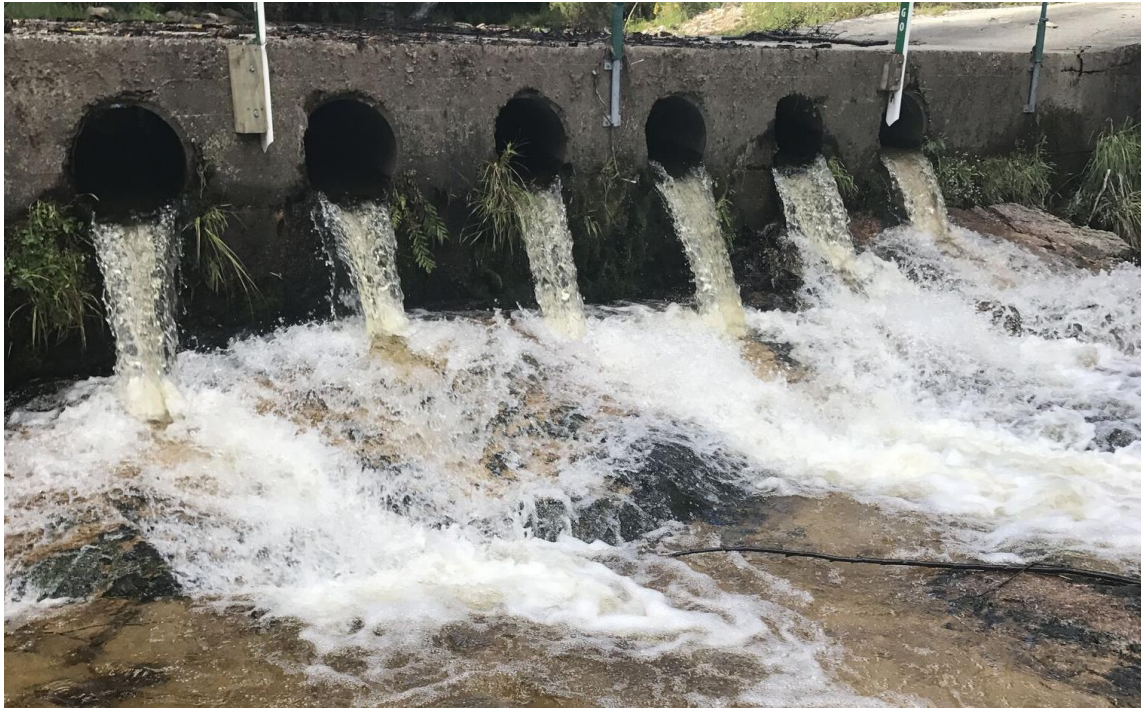
Figure 9- 6 pipe concrete splash culvert, high velocity 0.3-0.5m perch and large sediment build-up upstream. Has now been replaced with bridge due to the large sediment build ups and regular flooding of this crossing

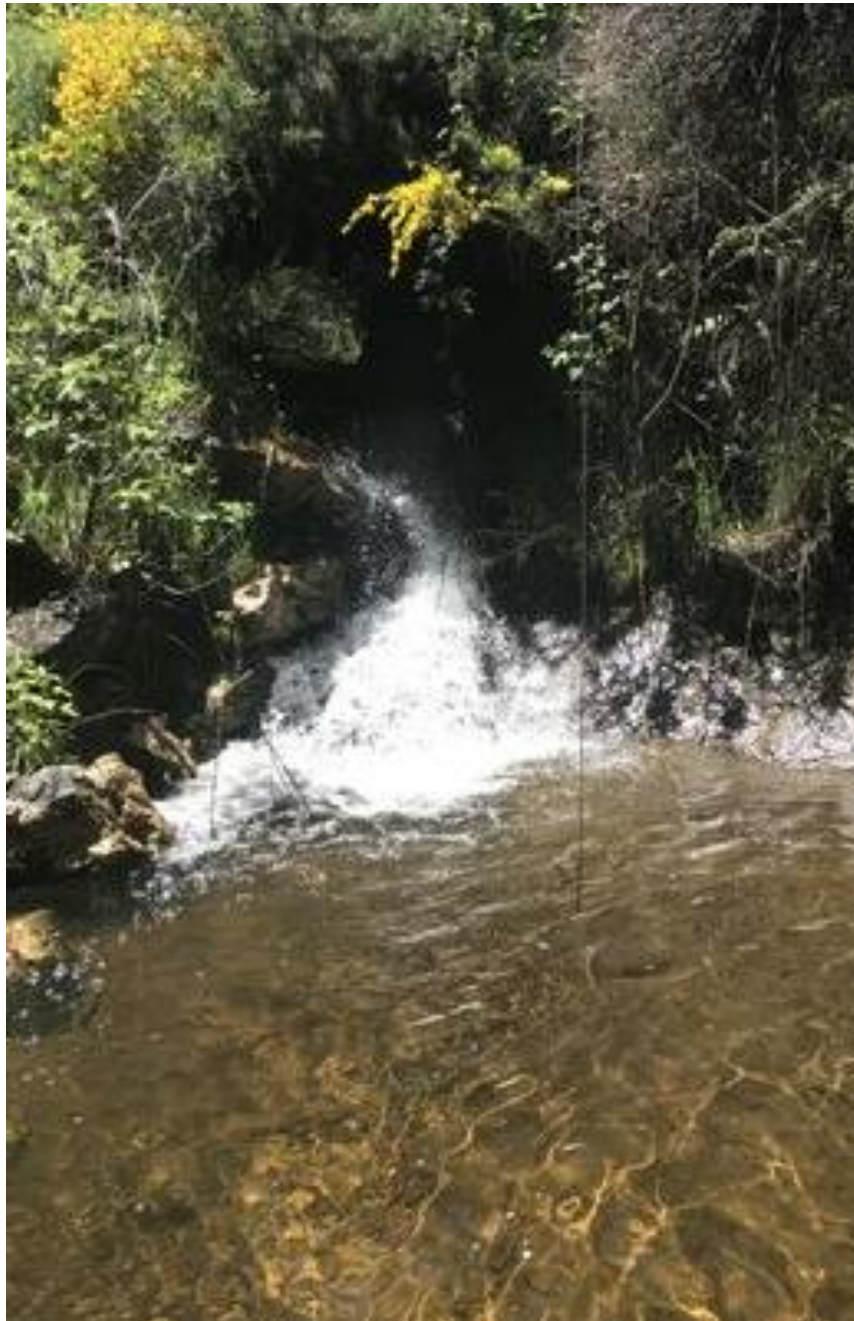
*Figure 11- Single 1200mm concrete culvert with a large perch which flows over a rock face.
Primary remediation method is through spat ropes.*

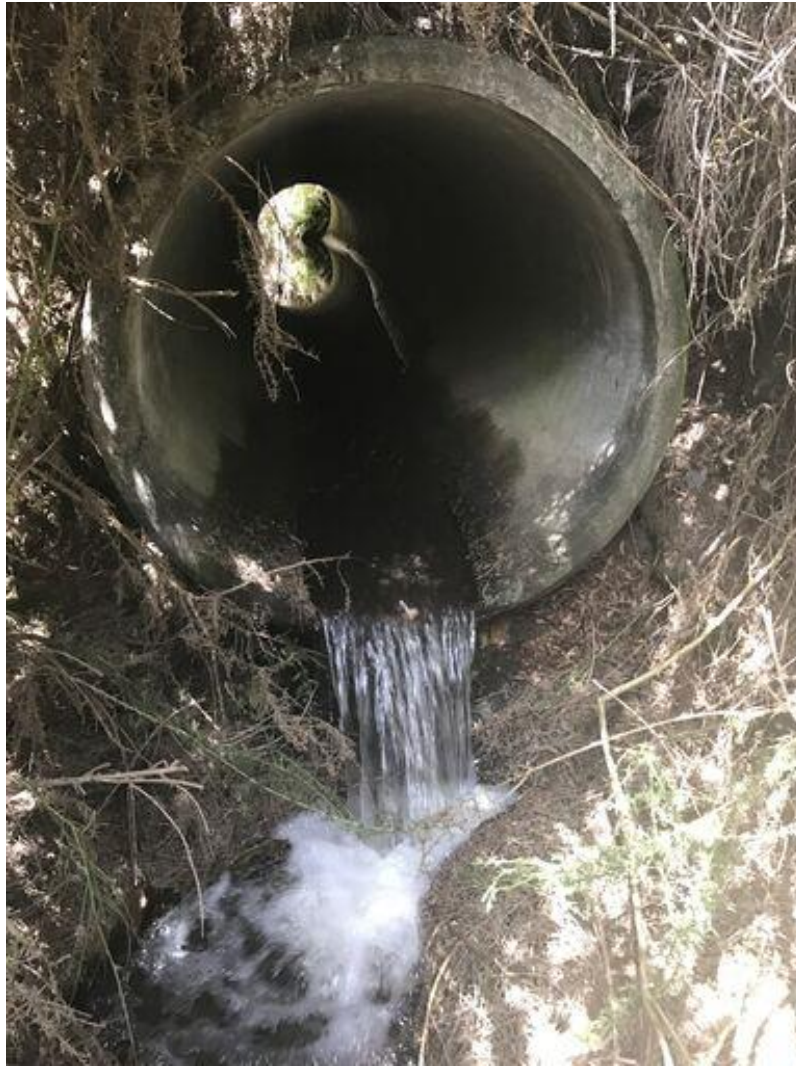
Figure 12- this medium size concrete culvert has a small perch and overhang. It was easily remediated through the installation of a fish mat and Spat ropes.

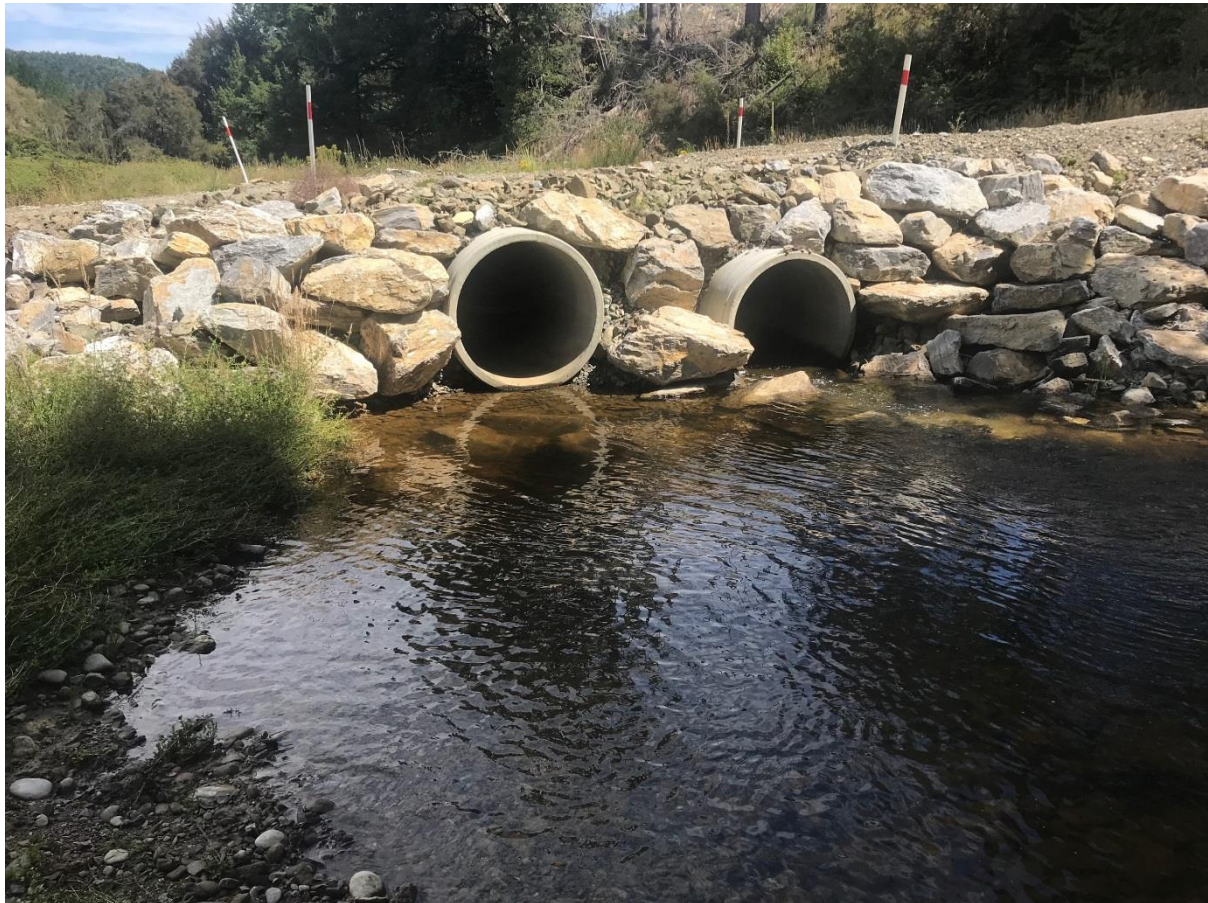
Figure 13- Newly installed concrete 2 pipe crossing. Second pipe is lower to aid fish passage

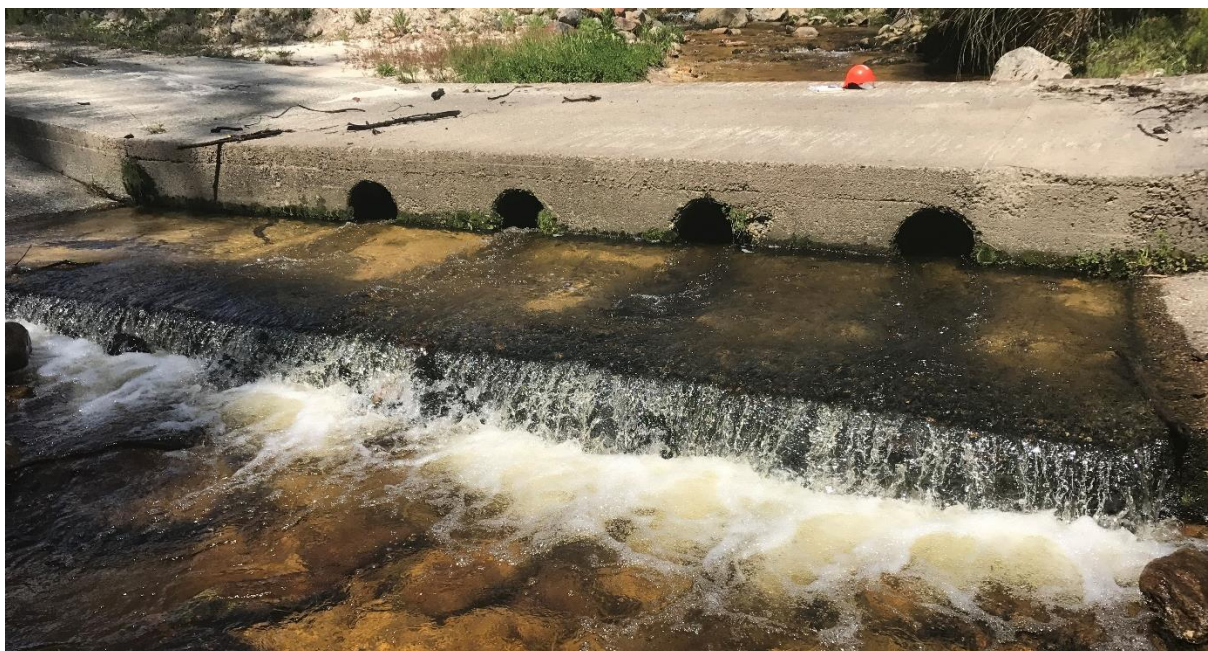
Figure 14- 4 pipe concrete splash culvert, apron slows velocity, but, creates small perch which has been remediated through creating a rock ramp at one end

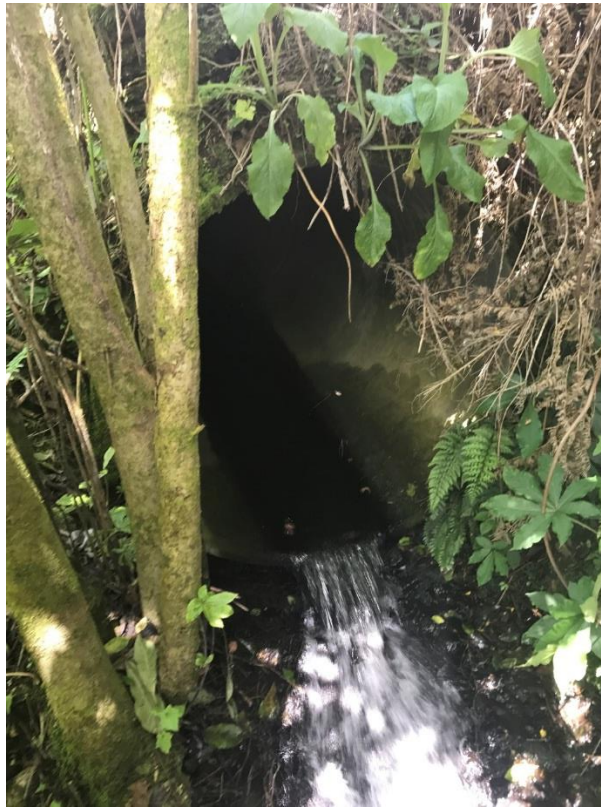
Figure 16- This medium size concrete culvert has a small perch and overhang. It was easily remediated through the installation of a fish mat and Spat ropes.

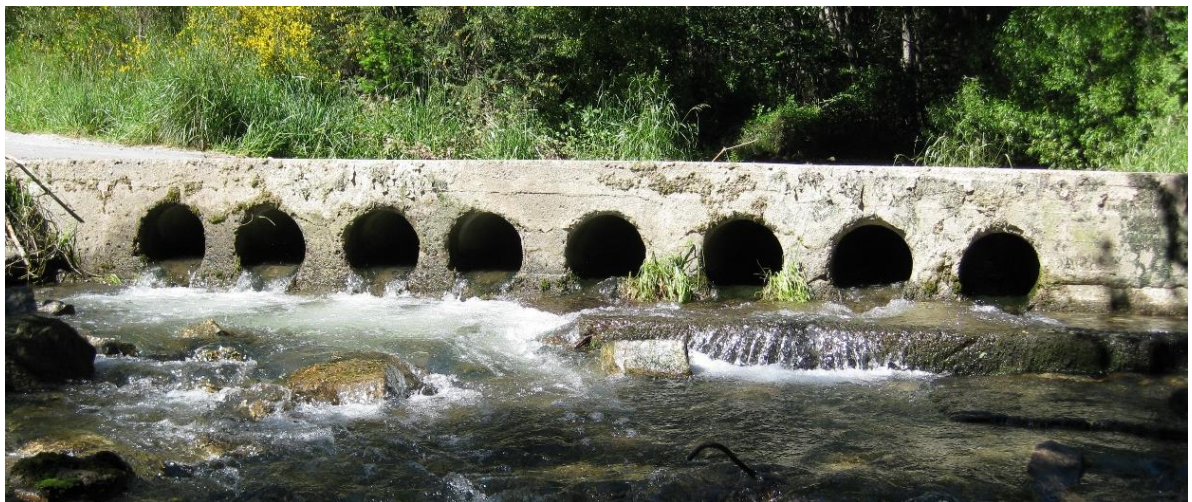
Figure 17- This concrete splash culvert with 8 pipes regularly blocks in flood events. It also has a high velocity which is increased by the lack of friction in the concrete pipes. Could be fixed through replacement or slowing the velocity in one pipe to aid fish passage.

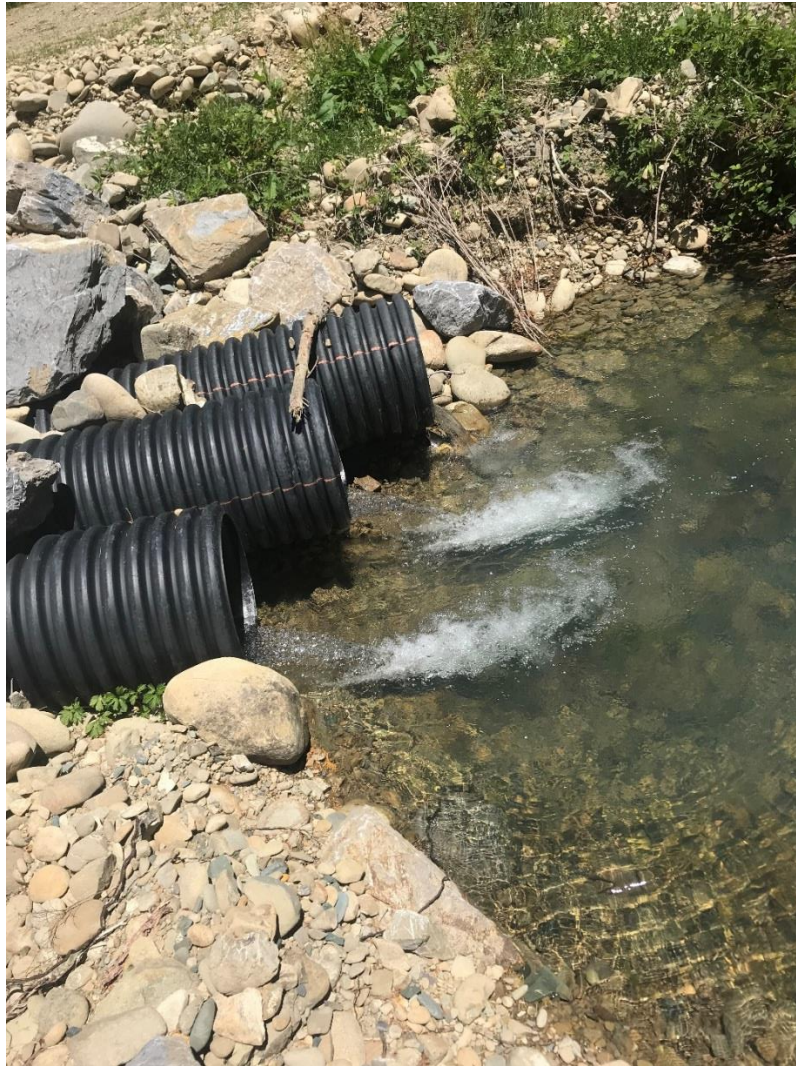
Figure 18- These three plastic pipes were a temporary culvert and have now been removed. Their passage issue is that they are perched with an overhang.

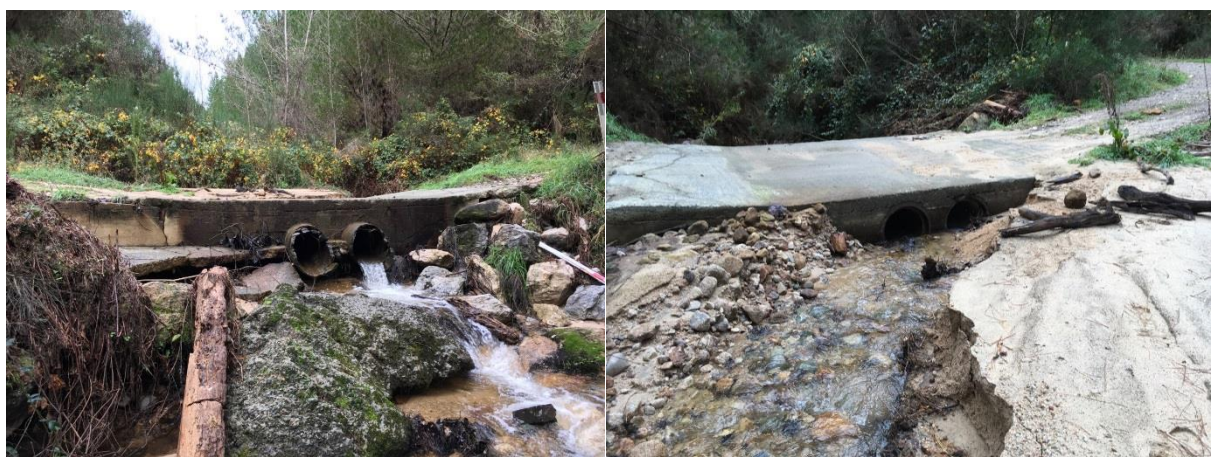
Figure 19- This crossing is a concrete splash with 2 pipes. It has been damaged and has a large overhang, perch and velocity in 1 pipe while the other is blocked by a silt build up. This needs to be pulled out and replaced with a culvert designed for greater capacity.

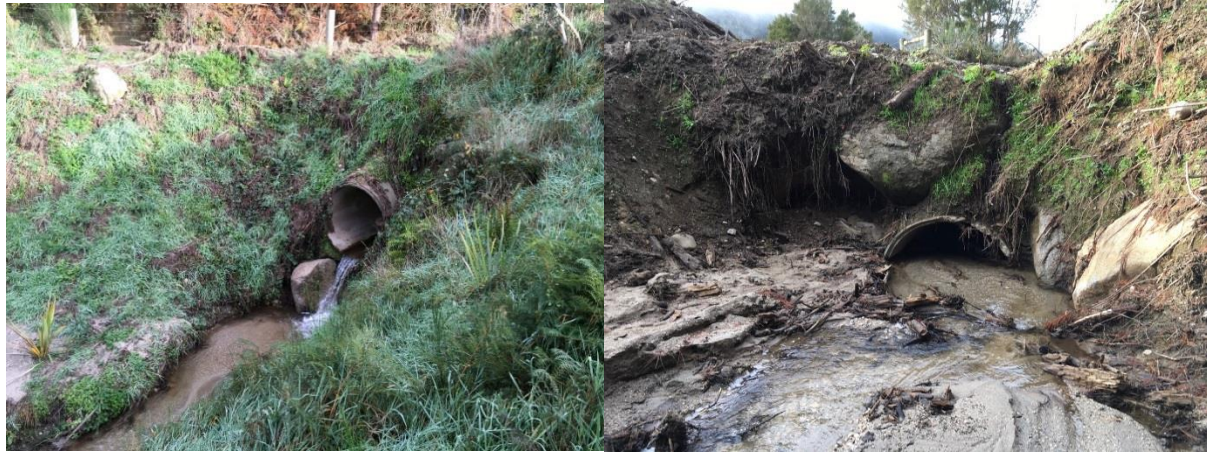
Figure 20- Single concrete culvert has large silt build up at inlet and large perch and overhang at outlet. Outlet is good for fish mat and spat ropes.

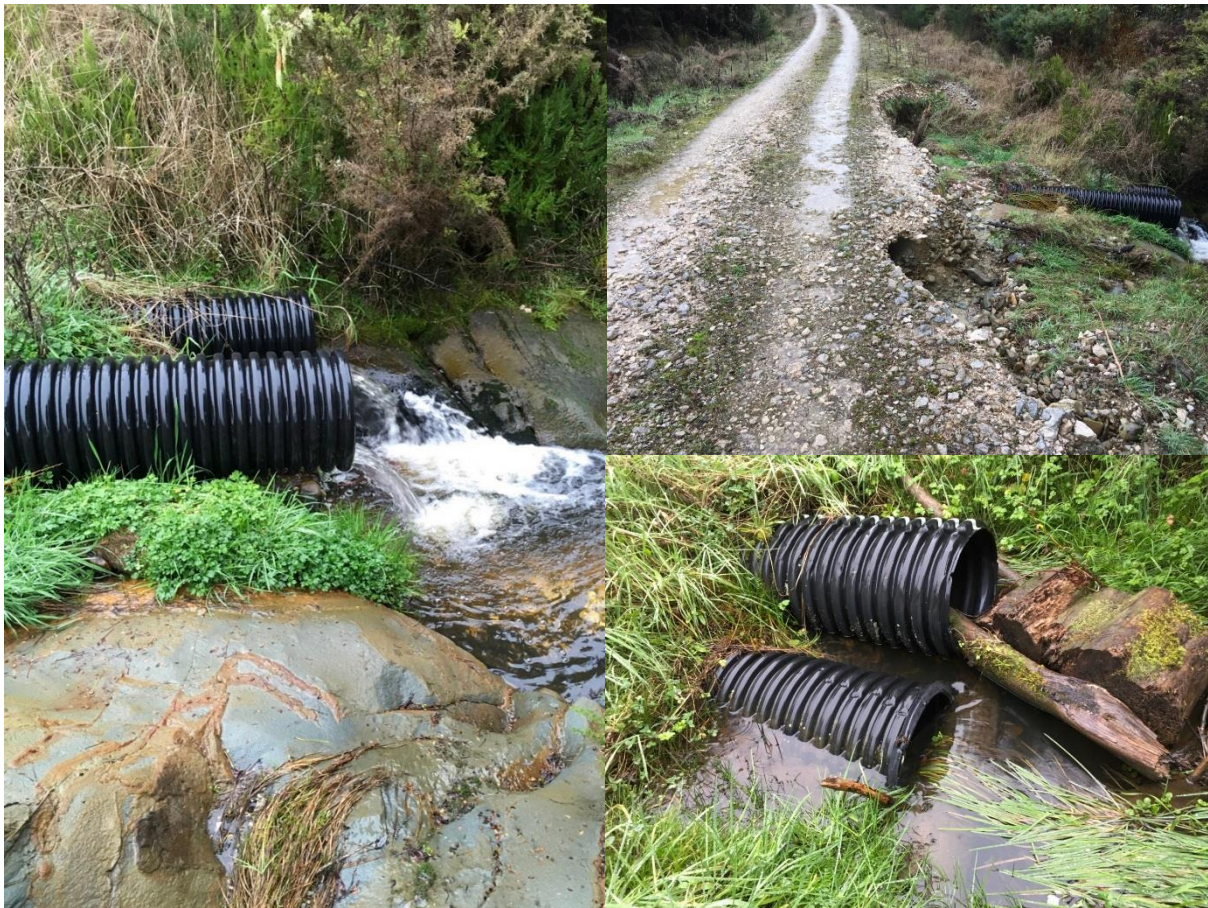
Figure 21- Inlet of these 2 plastic pipes are blocked with woody debris do not appear to sit in a defined stream channel. The road has been eroded away when this crossing floods. The outlets are also perched and have an overhang.

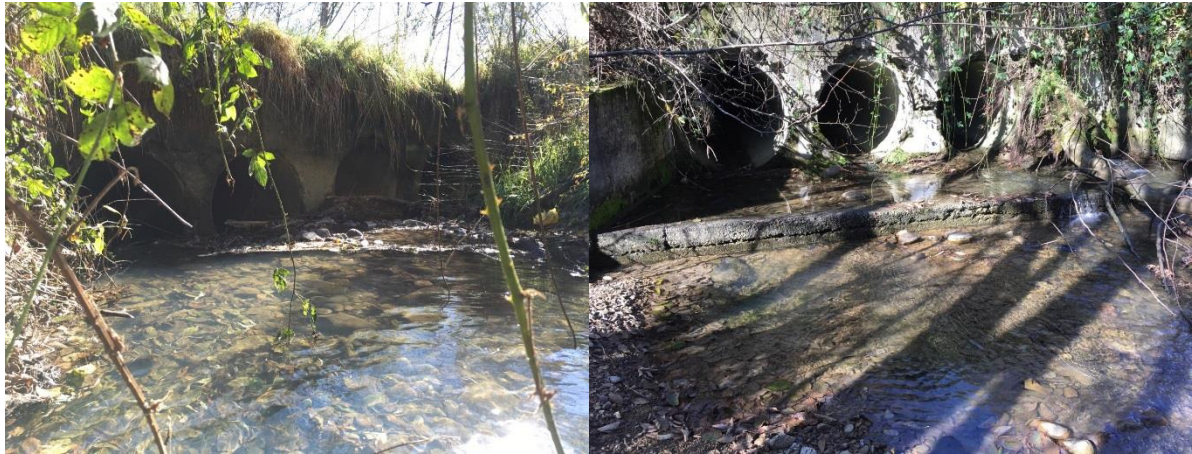
Figure 21- This large concrete crossing with 3 pipes has an apron with a small perch on the outlet this perch could be quickly built up with a rock ramp.

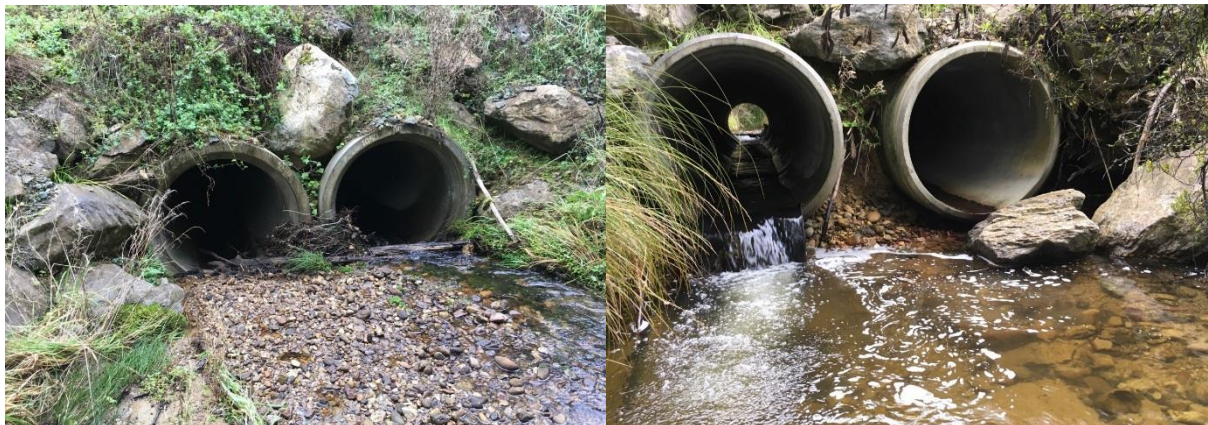
Figure 23- This double concrete culvert is perched and overhung. It has already been remediated with a fish mat.
