R.J. BLACK,
WAIPA SAWMILL

WINDTHROW SALVAGE - WAIPA SAWMILL

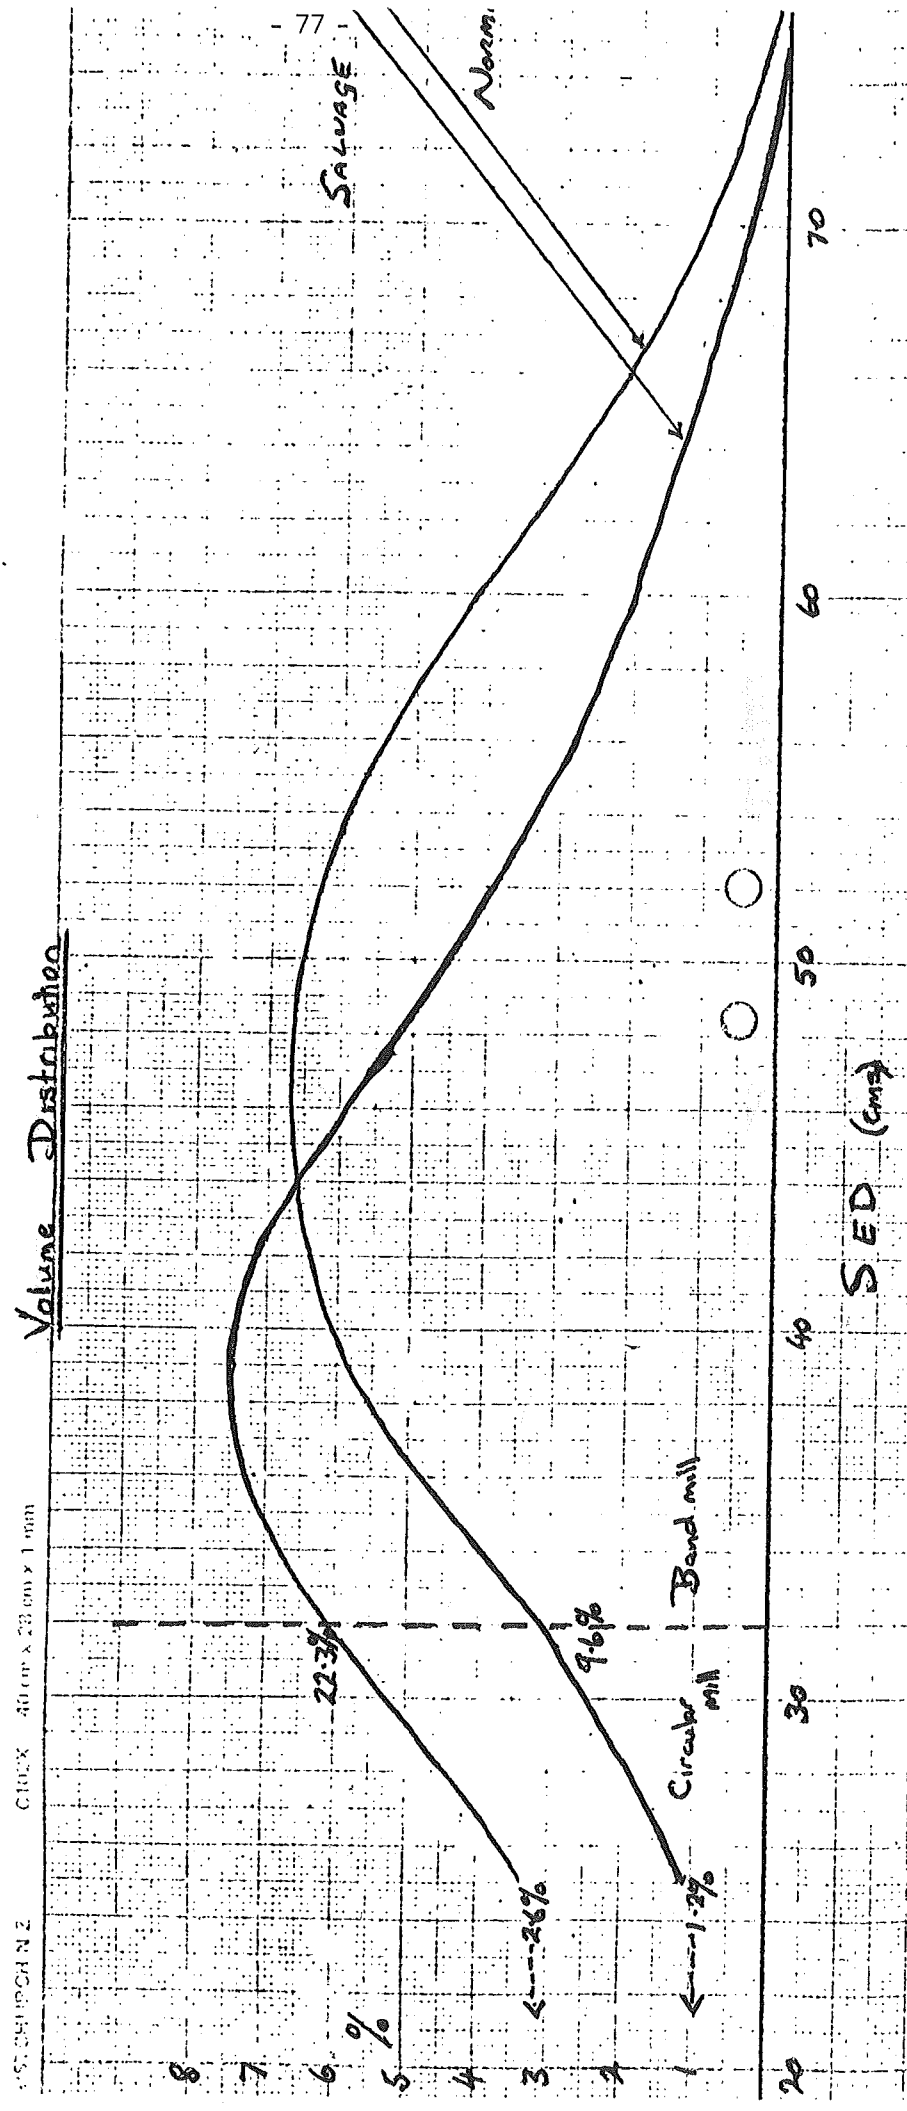
LOG SIZE - MAIPA SAMMILL 1 Windthrow Salvage

The results of scaling studies performed at the mill (graphs appended) clearly show the dramatic change in log size with respect to both small end diameter and volume. The lines marked at the SED point 35cm is the cut-off used under normal circumstances to segregate logs for the Circular Mill (less than 35 cm) and the Bandmill (35 cm and larger).

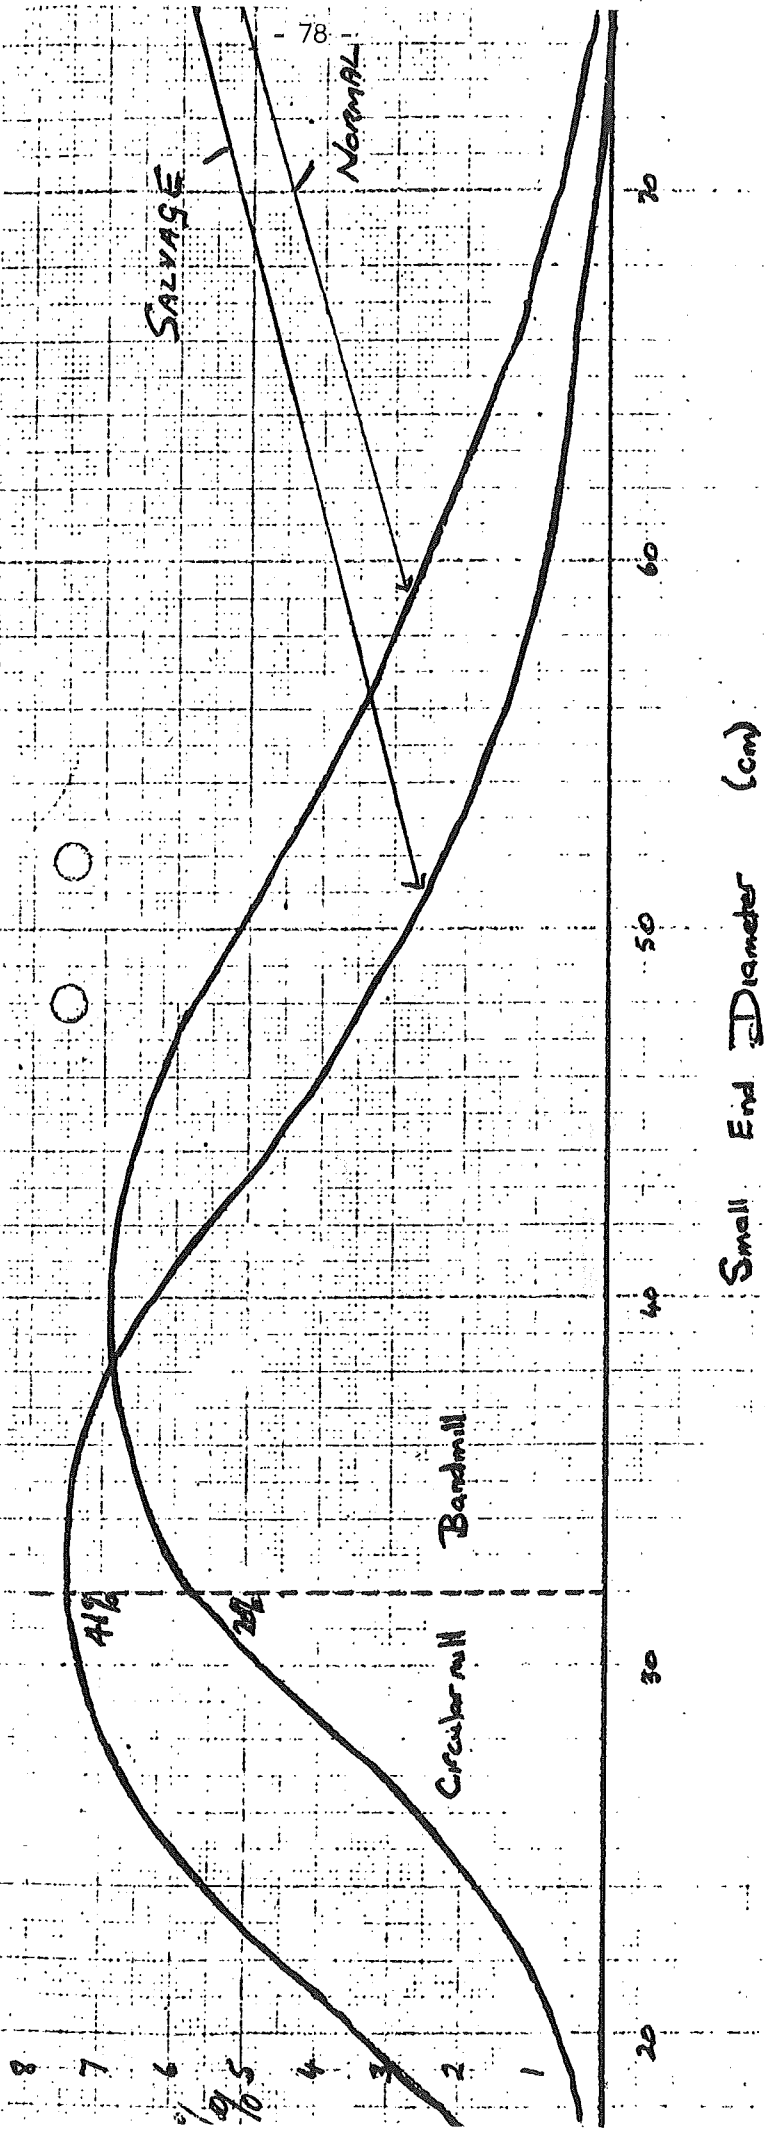
LOG SIZE - WAIPA SAWMILL - Windthrow Salvage

Small End Diameter Distribution
