EXCAVATOR ANCHOR TIPOVER

January 2018

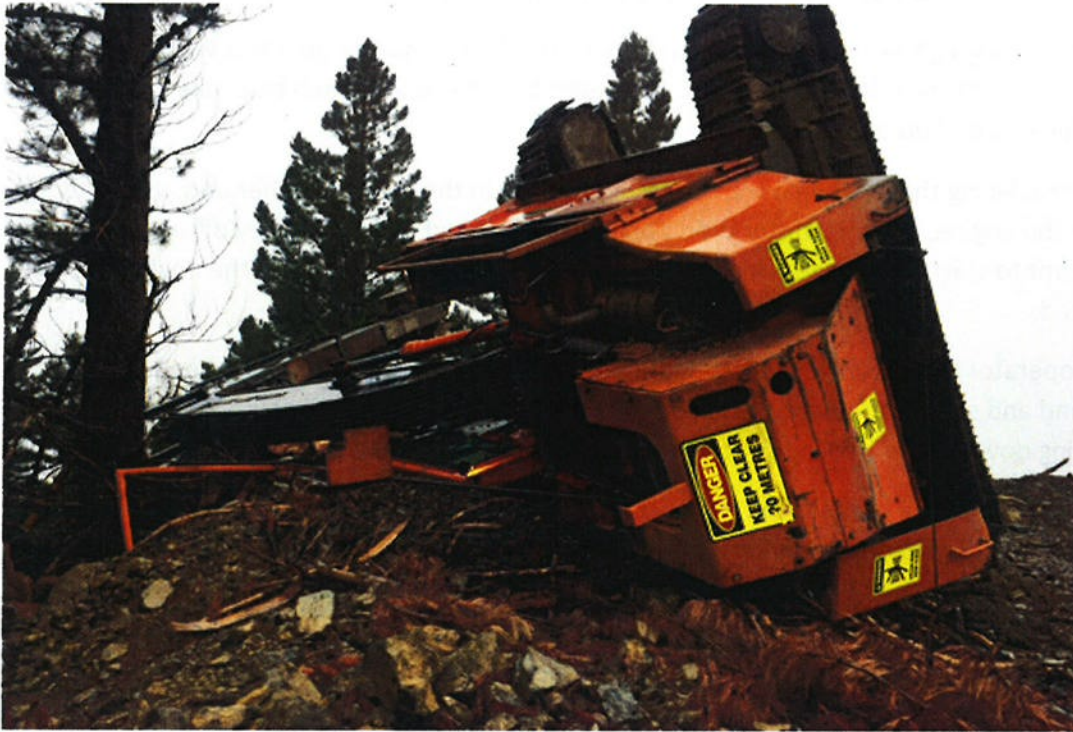
Winch Assist Machine (anchor) pulled onto its side by tethered feller buncher.

Harvester operator had parked up his machine on the hillside and got out of the machine to change the chain on the felling head. When he got back into the feller buncher he forgot to reset the winch set switch. He drove forward putting full pressure on the winch machine, causing it to rotate about the bucket and roll onto its side. Operator said that he simply forgot to turn winch on to automatic feed after getting back in.

Feller buncher was situated at a lead angle of approximately 17 degrees from the winch and on a slight slope (~8 degrees).

The anchor machine's track gear was perpendicular to line of pull. The distance between the track frame and bucket was between 8-9 m. No sheave at bucket.

Design improved – additional sheave added to boom just above the bucket.

Further training in winch set up.

Engineering / system change to ensure winch is turned back into automatic feed
