DAMAGED TETHER ROPE

November 2018

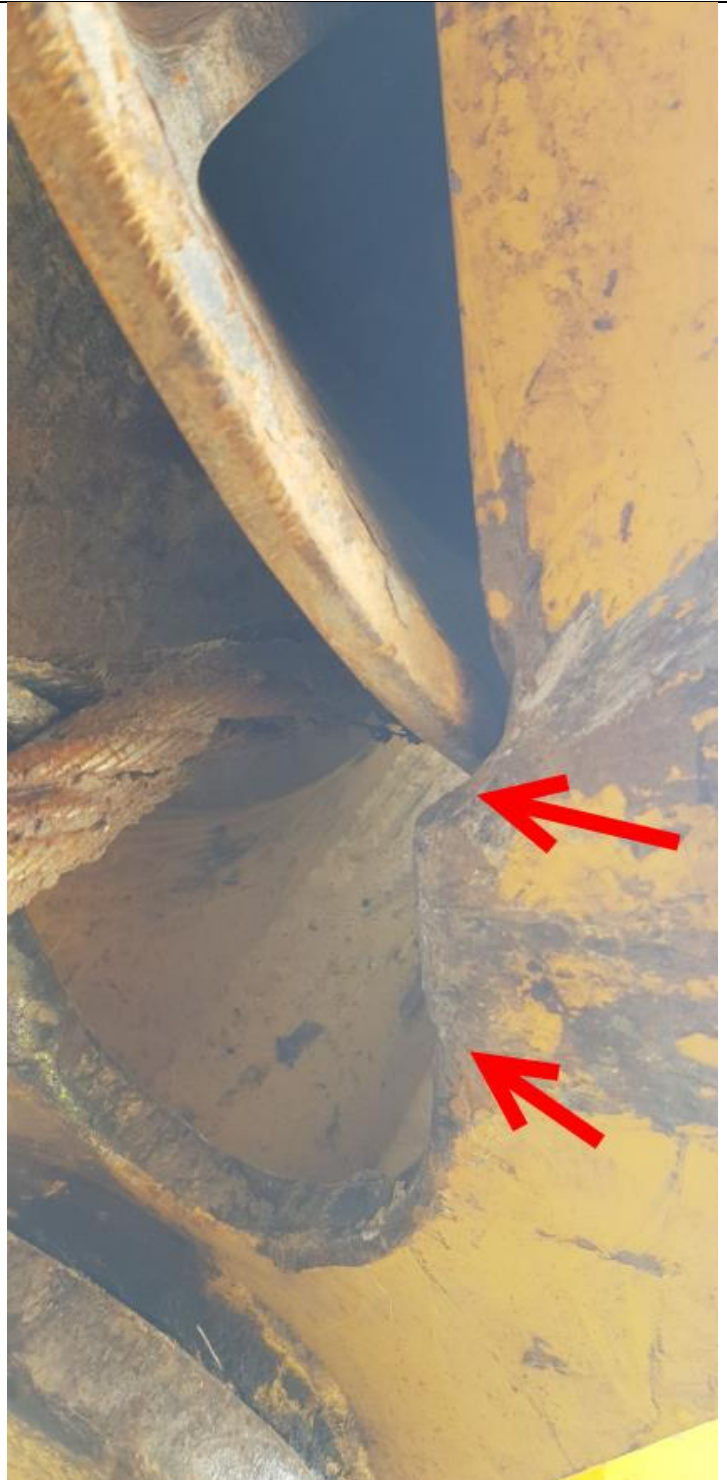
Tether rope was pinched in anchor machine sheave housing resulting in severed strands. Rope required cutting and re-splicing.

Not enough room to bring 909 harvester to the top of the hill so had to reposition anchor to make space. In slewing the tether anchor machine with ropes still attached to felling machine, the ropes got caught on the stumps. The slewing motion coupled with tension on the ropes has resulted in the rope rubbing on the side of the sheave housing.

Pay attention to rope tension out of the sheave and avoid it tensioning at too much of an angle as it can pull the rope up into the fairlead

Fairlead needs to be redesigned or replaced to avoid it happening again (discuss with manufacturer).

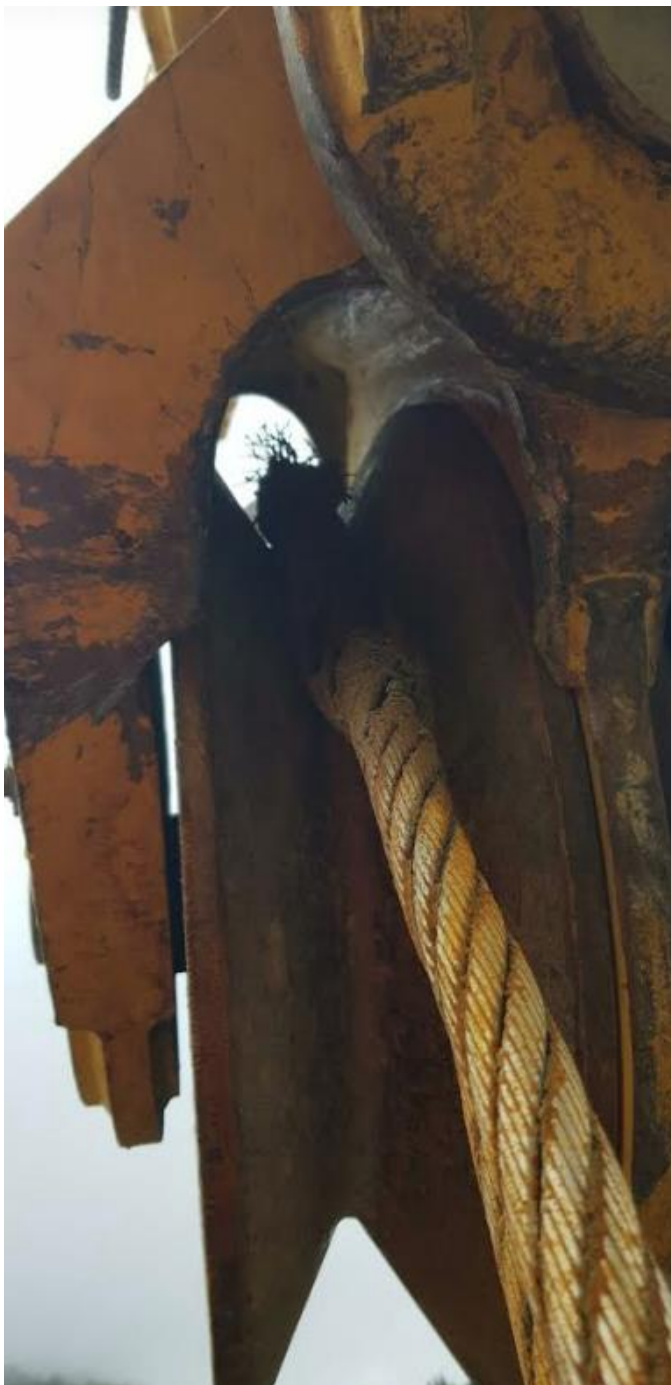
view from ground looking skywards through sheave
