# WINCH MOUNT FAILURE - ROBS

July 2018

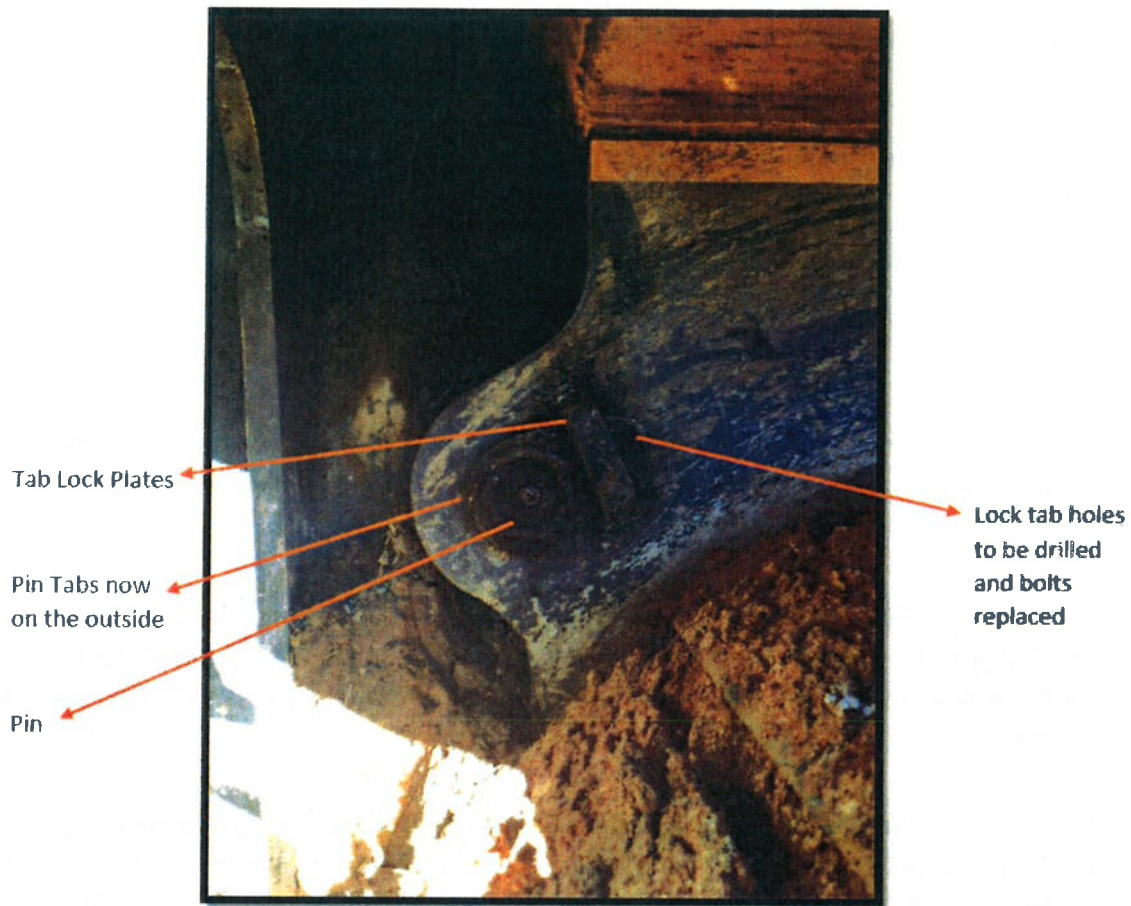
Winch assembly on the ROBS bulldozer anchor machine was found to be faulty (on arrival at the site). On carrying out a visual inspection before using it (to blade the chute) the operator noticed a hole where he thought a pin should be. On inspection of the opposite side, he noticed the pin there had also worked out and not supporting anything. (These pins were the top mounting pins that hold the winch to the dozer). The bottom two pins were still in properly, but the bolt in one had broken and the tab had spun around.

The pin lock bolts had broken and the pins had worked loose due to winch frame movement. It is thought that the holes for the pins could have been originally machined with too much clearance, or being the original Liebherr pins, they could have been worn to start with.

The mounting pins and pin lock bolts had not been checked. The 4 pins that mount the winch unit to the dozer are not greased working pins, they are mount pins only.
