EROSION SOURCES AND SEDIMENT PATHWAYS TO STREAMS ASSOCIATED WITH FOREST HARVESTING ACTIVITIES IN NEW ZEALAND

Prepared for the New Zealand Forest Owners Association

June 2017

Project Final Report

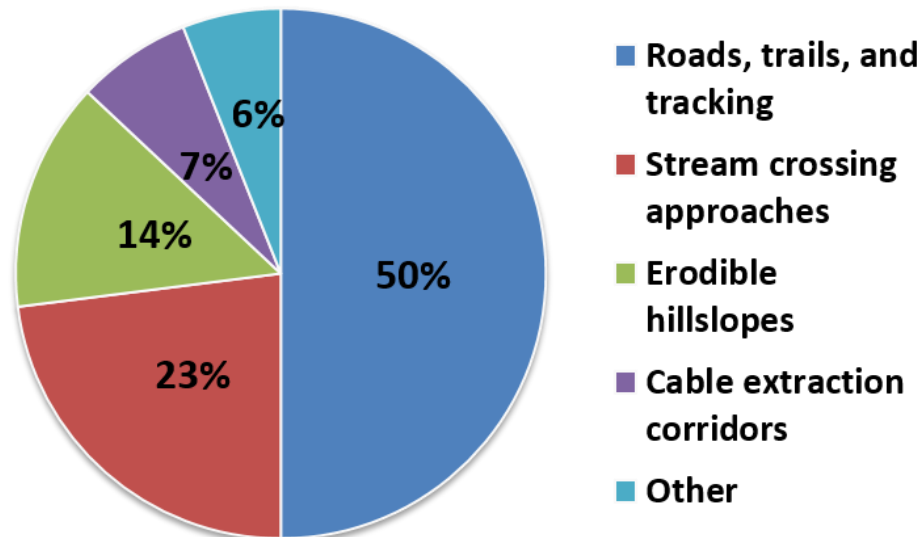
Figure 1. Breakthrough sources and their relative frequency. N = 53 for 'Roads, trails, and tracking', 24 for 'Stream crossing approaches', 15 for 'Erodible hillslopes', 7 for 'Cable extraction corridors', and 6 for 'Other'.

Half of the breakthroughs found in this study were caused by concentrated runoff from roads, skid trails, or machine traffic disturbance on the hillslope (Figure 1). An additional 23% of breakthroughs occurred where roads and trails crossed streams. Thus, 73% of breakthroughs were associated with roads, trails, and machine tracks on the hillslope.

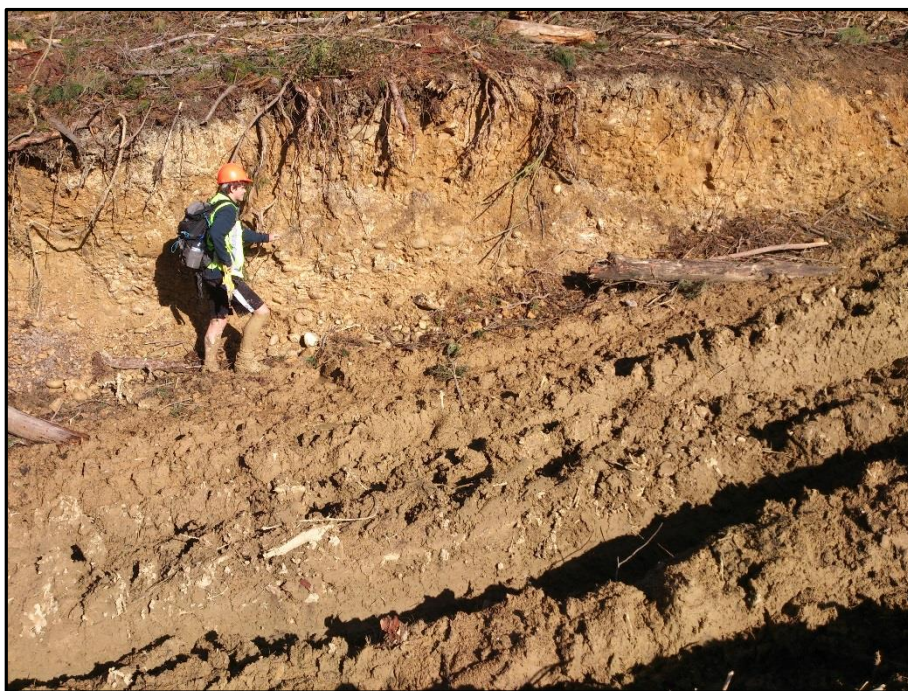
Figure 2. Photo depicting a badly rutted skid trail post-harvest. Photo: Kristopher Brown.

Erosion estimates ranged from 0.5 to 13 tonnes/hectare/year for truck road surfaces, 0.9 to 20 tonnes/hectare/year for truck road ditches, and 6 to 315 tonnes/hectare/year for skid trail surfaces. The median potential erosion rate for skid trails was 44 times greater than truck road surfaces and 18 times greater than truck road ditches. Skid trails that led to breakthroughs were steep (median = 16.5% slope) with poor surface cover (0 to 30%) (Figure 2). This finding highlights the importance of closing skid trails properly upon harvest completion, especially at stream crossings. Installation of water bars and turnouts to control surface runoff and application of slash to skid trail approaches can be used to reduce the potential for sediment delivery at road-stream crossings.

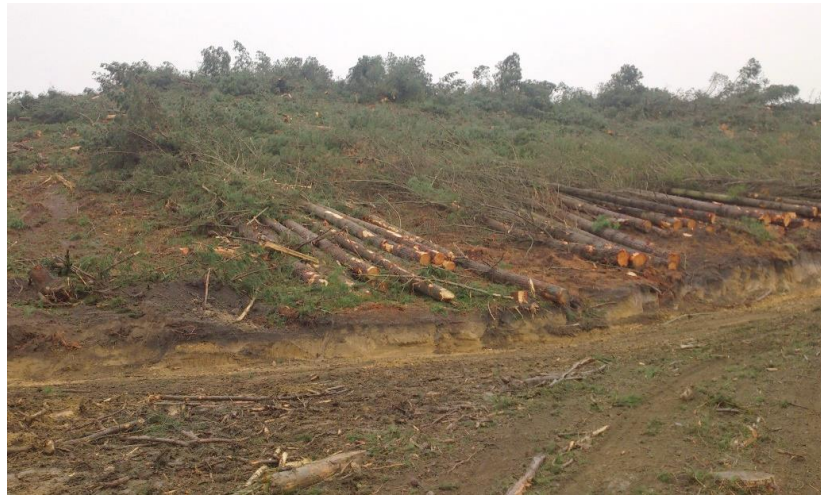
Figure 3. Bunched stems next to a skid trail awaiting extraction from a grapple skidder.

An example of minimising tracking associated with ground-based harvesting is to use shovel logging. Less tracking is required because stems can be shovelled to a skid trail and bunched in preparation for extraction (Figure 3).

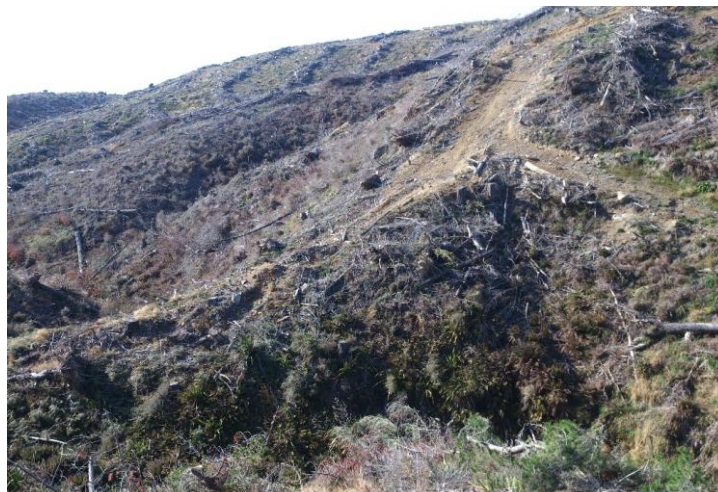
Figure 4. An example of a relatively steep ground-based harvest where skid trail disturbance was limited to ridge tops.

Further to careful road location and control of water erosion upslope, streamside management zones (SMZs) can provide a variety of protective functions, including sediment trapping, bank stability, shade (water temperature control), and food and habitat for aquatic organisms. Visser and Fenton (1994) provide a practical guide for forest managers to identify important values for streams and streamside areas, rank stream importance based on those values, determine an appropriate SMZ width, and prescribe SMZ requirements to protect the identified values. For example, even though harvesting of radiata pine may extend to the stream channel, minimizing machine traffic within a few meters of the stream can protect stream banks, while leaving some type of vegetative or slash barrier adjacent to the stream can aid in filtering surface runoff (Figure 4).

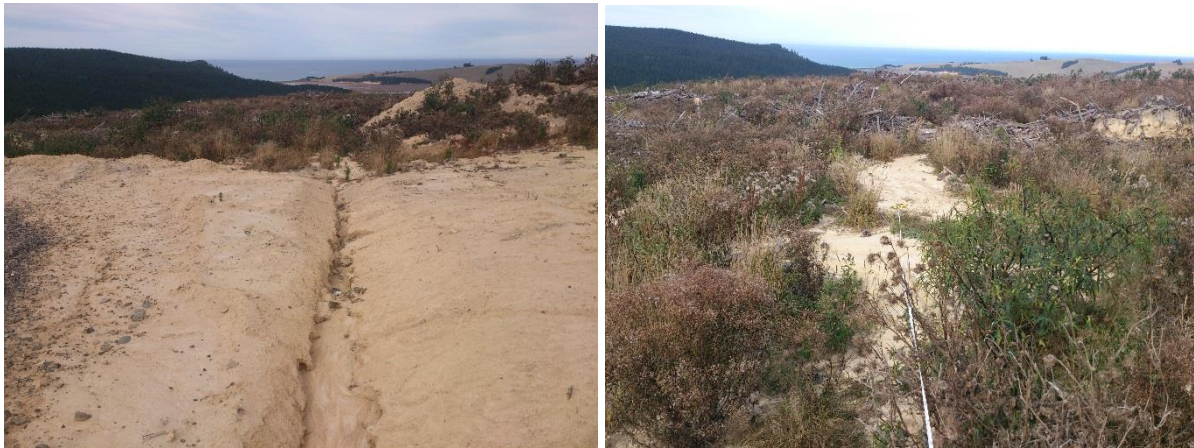
Figure 5. Left: At a road curve, a cut-out moves water from the ditch into an area in the cut-over with flat topography and high surface roughness, ideal for trapping sediment. Right: Sediment is trapped and stored in the cut-over.

emphasis on controlling water in small amounts and reducing surface runoff velocity can help to reduce the occurrence of sediment breakthroughs, or at least mitigate their impacts on water quality. When it comes to road surface runoff, think “Slow it down and spread it out” (Figure 5). This can be achieved by spacing water control structures (e.g. cross-drain culverts, cut-outs, or water bars) according to road gradient and soil erodibility. As road gradient or soil erodibility increases, road drainage structures need to be spaced at shorter intervals.

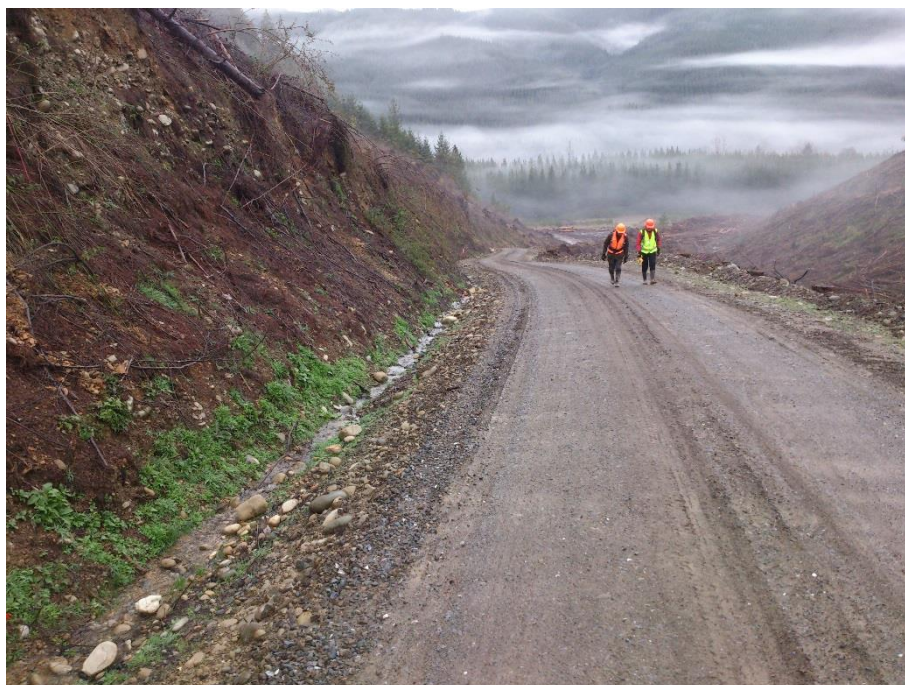
Figure 6. A secondary forest road with a good shape (crown), which moves half of the road surface runoff to the inside ditch and half to the fillslope (outer) side of the road. Water in the ditch drains to a series of cross-drain culverts, while surface runoff from the outer half of the road is relieved by a series of cut-outs. Note that the ditch also concentrates subsurface flow

from the hillslope above the road, which may have a much larger catchment area than that of the road surface itself. The spacing of road drainage structures needs to take this into account.

In addition to appropriate spacing of road drainage structures, the shape of the road profile is important for reducing runoff volume and velocity. For example, a crowned road sheds half of the road surface runoff to the inner and half to the outer sides of the road. (Figure 6).

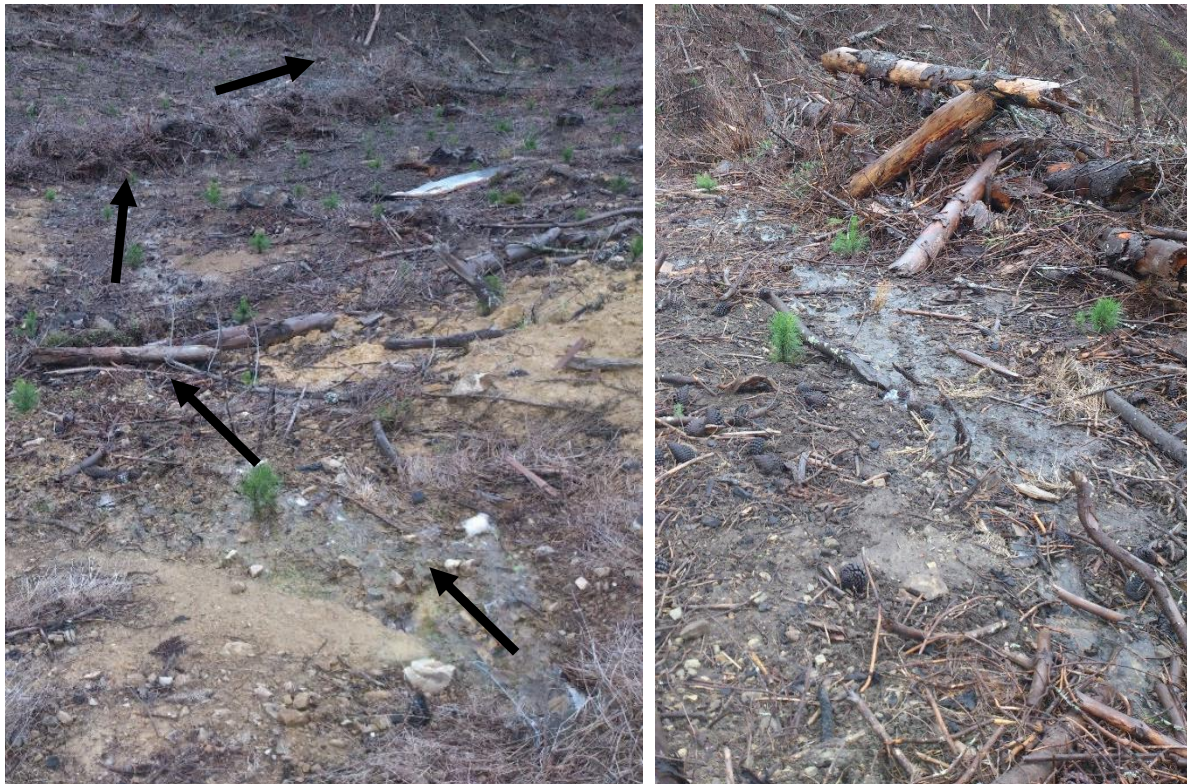
Figure 7. Left: Runoff flowpath on the hillslope below a cross-drain culvert. The slope is moderately steep (21 degrees) and surface cover is low after root raking and replanting, but surface runoff must travel 95 meters on the hillslope and pass through a slash windrow on its way to the stream. Right: Concentrated surface runoff reaches the stream, but it is flowing clean.

Locating road drainage structures to avoid discharging surface runoff directly or indirectly (e.g. through ephemeral gullies) to stream channels is also important to reduce road-to-stream hydrologic connectivity. A cut-over with an intact forest floor is a good example of a desirable receiving environment because its stability, roughness, and high infiltration capacity improve infiltration of runoff and trapping of sediment. Other desirable characteristics for receiving environments include gentle slopes, lack of convergence, and some distance between the drainage outlet and the stream (Figure 7).

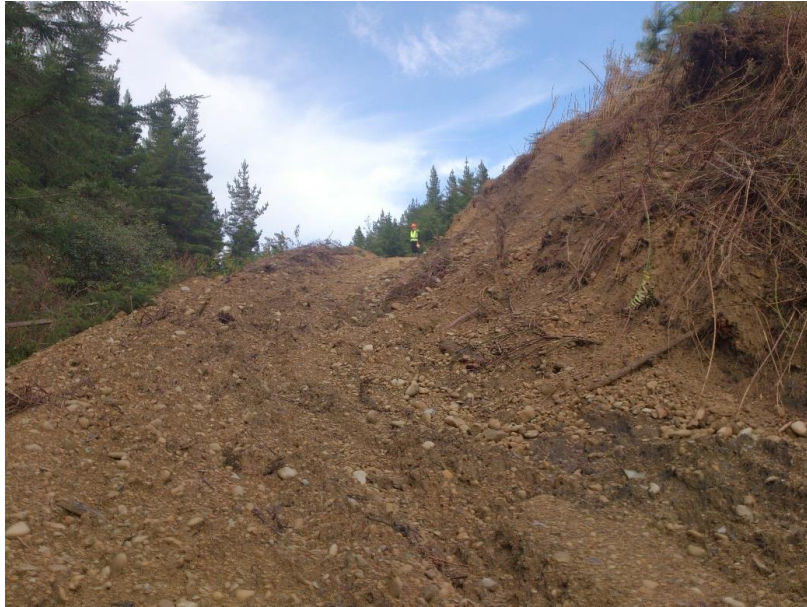
Figure 8. This temporary stream crossing approach was steep (33% slope), with no water control, and poor surface cover (20% cover). The potential erosion rate was estimated at 204 tonnes/hectare/year.

While just 10 of 35 skid trail approaches to stream crossings contributed to sediment breakthroughs in this study, the ones that lead to breakthroughs did so in a big way (Figure 8). For example, the median potential erosion rate for skid trail approaches that led to breakthroughs was 71 tonnes/hectare/year versus 1.6 tonnes/hectare/year for the surfaces of log truck roads. Closure of bladed trails at stream crossings should include drainage structures, such as water bars, plus some type of surface cover (Figure 9).

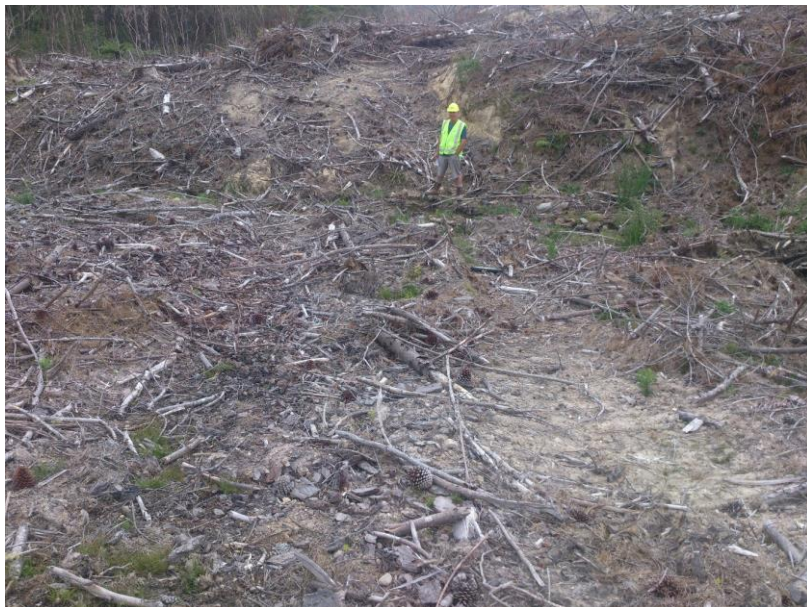
Figure 9. This temporary crossing has gentle approaches to the stream, slash barriers were used to disrupt concentrated surface runoff, and logging slash was used to provide surface cover.

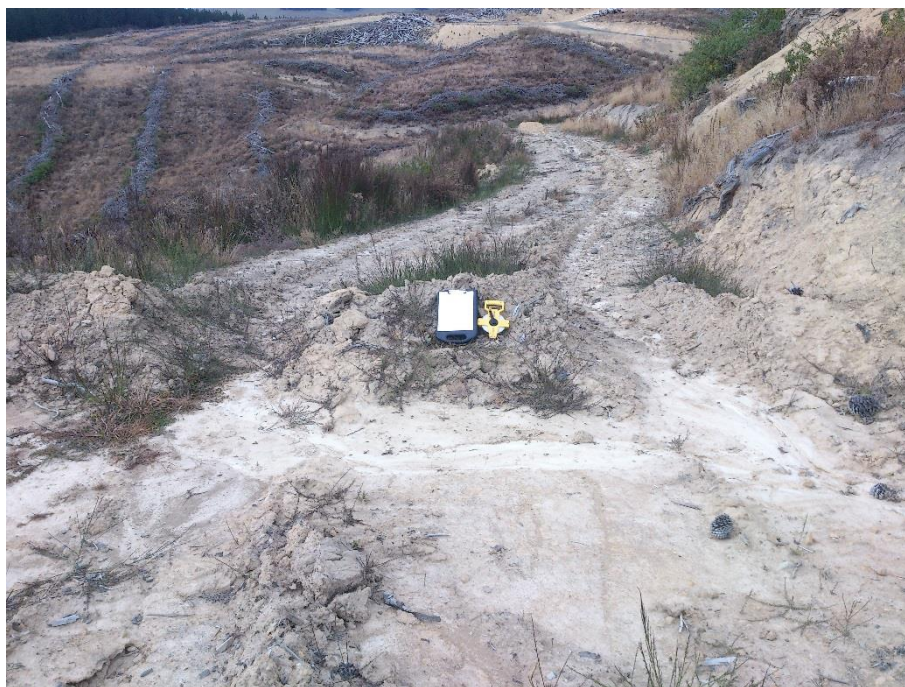
Figure 10. Surface runoff passes through this water bar because it has been compromised by traffic.

For skid trails and other temporary tracks, water bars, cut-outs, and other erosion control practices need to function for about two years post-harvest (Figure 10). By then, harvested sites have revegetated and exposed soil has become less erodible (i.e. easily transported sediment has been washed off). Therefore, it is important to audit the implementation and functioning of erosion and sediment control practices prior to machines moving off site, as well as periodically thereafter (e.g. following heavy rainfall events).

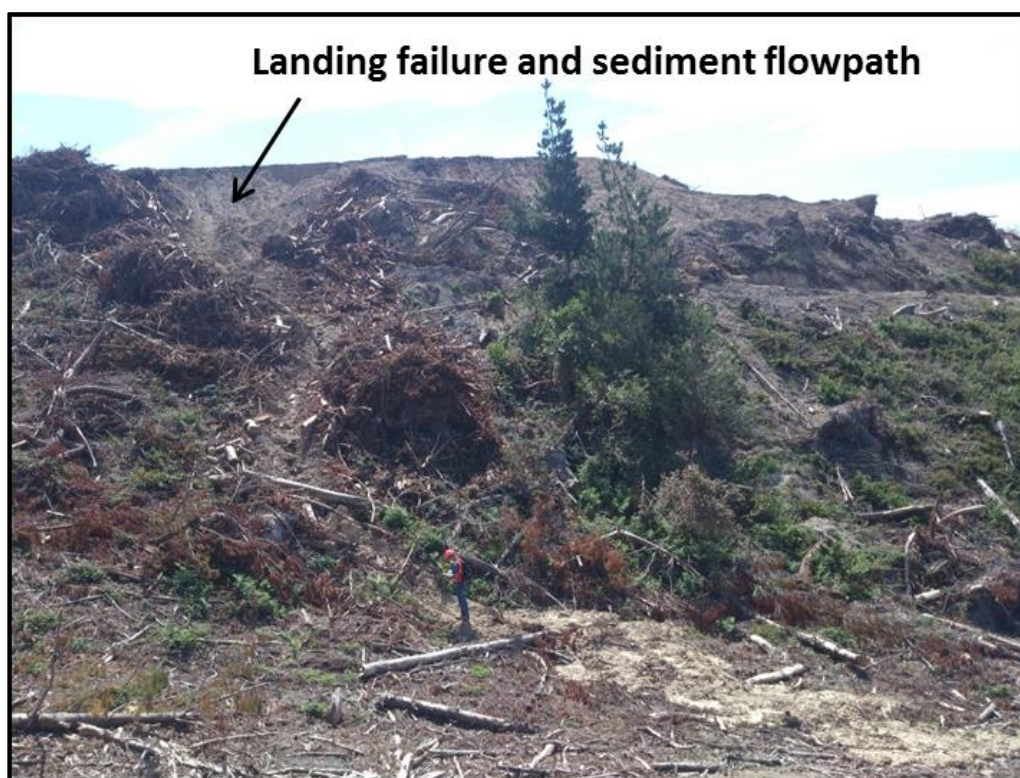
Figure 1. Example of a sediment breakthrough to an ephemeral stream channel. This breakthrough resulted from a landing failure. Photo: Kristopher Brown.

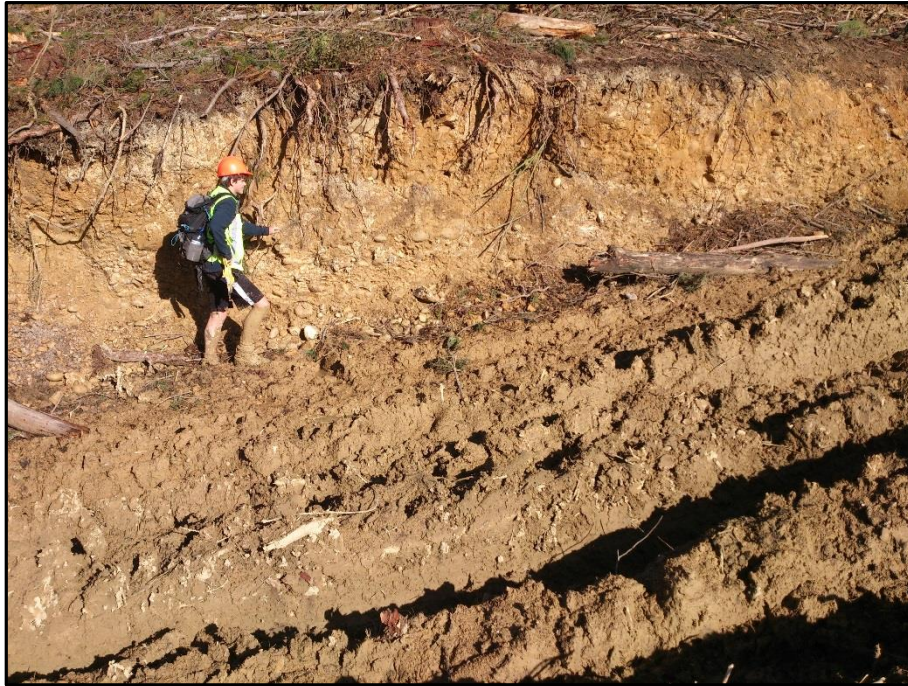
Figure 2. Photo depicting a badly rutted skid trail post-harvest. Photo: Kristopher Brown.

crossing constructed in highly erodible silty loam soils. An additional 10 breakthroughs resulted from naturally-occurring erosion features (i.e., many small land slips, rills and one gully) with no obvious connections to harvesting or road construction activities. At the other problem site, most of the breakthroughs were associated with deep rutting from skid trails and machine traffic near the stream with no provisioning of surface cover during site closure (Figure 2).

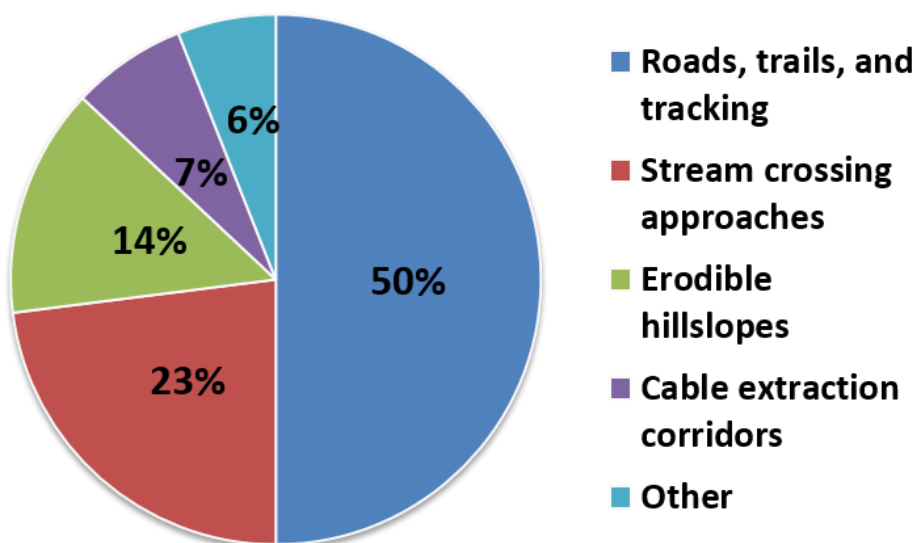
Figure 3. Breakthrough sources and their relative frequency. N = 53 for 'Roads, trails, and tracking', 24 for 'Stream crossing approaches', 15 for 'Erodible hillslopes', 7 for 'Cable extraction corridors', and 6 for 'Other'.

Most breakthroughs (50%) were caused by concentrated runoff from roads, skid trails, or machine traffic disturbance on the hillslope (Figure 3). An additional 23% of breakthroughs occurred where roads and skid trails crossed streams. Thus, 73% of breakthroughs were associated with roads, trails, and machine tracks on the hillslope. These findings reinforce the importance of pre-harvest planning efforts to minimise earthworks, locate roads and stream crossings to avoid steep gradients, and maintain a buffer (e.g., an SMZ or slash barrier) between disturbed soil and streams. Such practices should reduce the occurrence of road-related sediment breakthroughs and reduce the severity of impacts to water quality. Furthermore, road-stream crossings represent easy targets that can be identified during the planning stage and BMPs can be prescribed for water and erosion control.

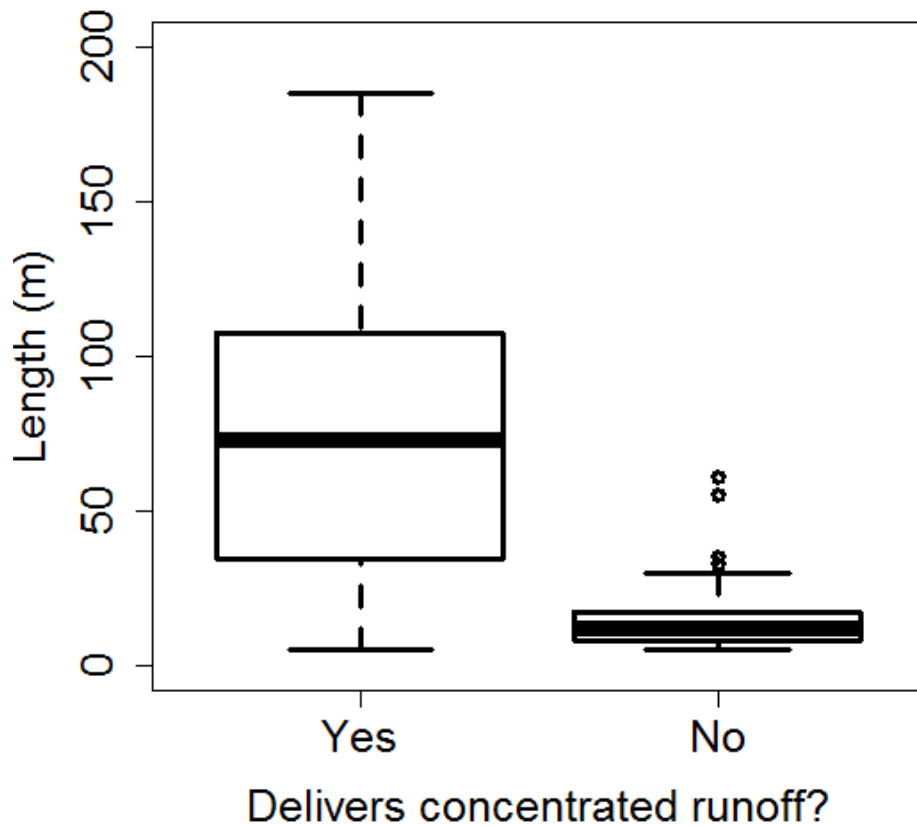
Figure 4. Box and whisker plots (showing the 5th, 25th, 50th, 75th, and 95th percentiles) of stream crossing approach length (m) in relation to whether or not the approach delivered concentrated surface runoff to the stream (n = 27 for 'Yes' and n = 29 for 'No'). Approach length was defined as the distance from the stream to the nearest road drainage structure (e.g. water bar, turnout, or culvert cross-drain) or topographic feature that moved surface runoff away from the road.

The distance from the stream to the nearest water control structure was important for understanding road-to-stream hydrologic connectivity. Median drainage length for road-stream crossings that led to breakthroughs was 73 m, ranging from 5 to 185 m (Figure 4). Conversely, median drainage length for road-stream crossings that did not lead to breakthroughs was 12 m, ranging from 5 to 61 m. These findings suggest that while it may be difficult to eliminate connectivity from log truck roads at stream crossings (due to their inherently compact design), the severity of water quality impacts can be managed by adding water control structures to reduce the drainage length. Sessions (2007) recommended reducing the drainage length at road-stream crossings to approximately 20 m. Of the 21 truck road approaches to stream crossings measured in this study, only 4 had a drainage structure within 20 m of the stream. For skid trail crossings, connectivity could be reduced by using overland (not bladed) skid trails where slope steepness allows, as well as installing cut-outs for water control and using slash or mulch for surface cover during road closure.

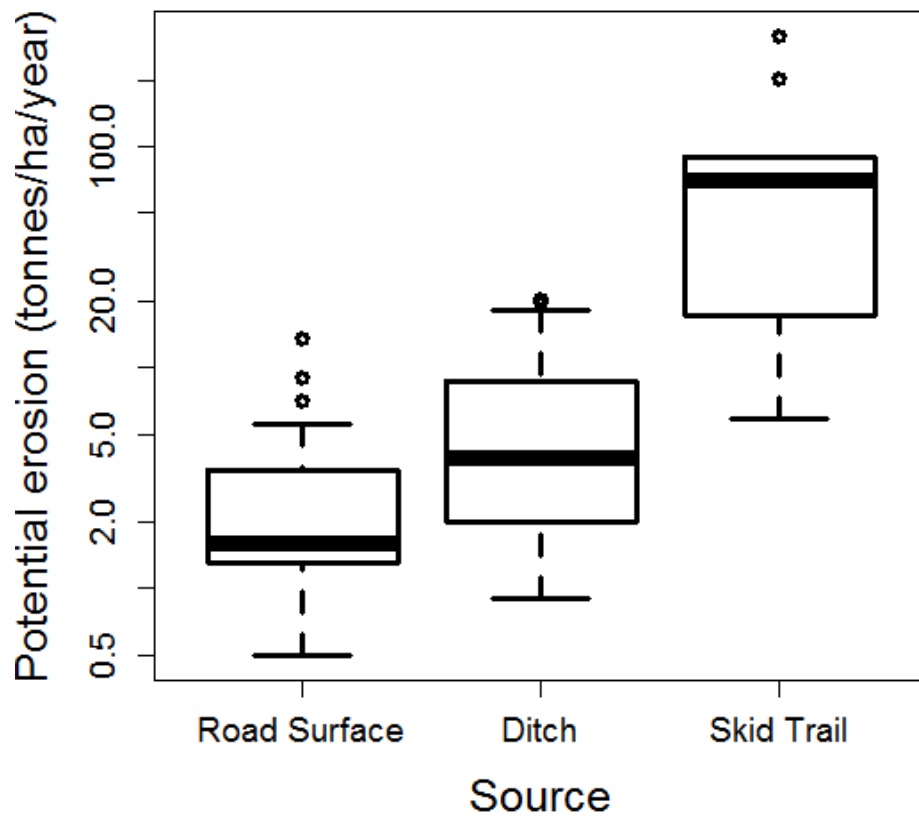
Figure 5. Box and whisker plots (showing the 5th, 25th, 50th, 75th, and 95th percentiles) of potential erosion rates of log truck and skid trail stream-crossing approaches (n = 17, 14, and 10, respectively, for truck road surfaces, truck road ditches, and skid trails). Each of these approaches contributed to a breakthrough.

Erosion estimates ranged from 0.5 to 13.4 tonnes/ha/yr for truck road surfaces, 0.9 to 20.1 tonnes/ha/yr for truck road ditches, and 5.9 to 314.8 tonnes/ha/yr for skid trail surfaces (Table 2). The median potential erosion rate for skid trails was 44 times greater than truck road surfaces and 18 times greater than truck road ditches (Figure 5) because skid trails that led to breakthroughs were steep (median = 16.5% slope) with 0 to 30% surface cover. This finding highlights the importance of closing skid trails properly, especially at stream crossings. Several studies have demonstrated the sediment-reduction efficacy of skid trail closure techniques, such as water bar installation, plus slash or mulch application (Sawyers, Bolding, Aust, and Lakel 2012, Wade, Bolding, Aust, and Lakel 2012, Vinson 2016).

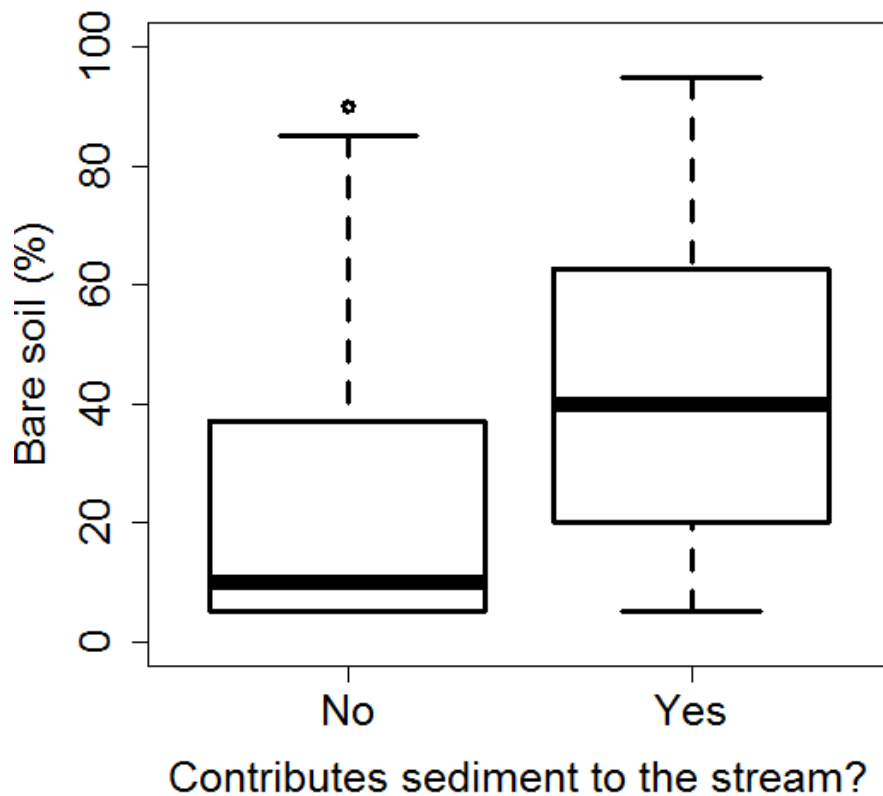
Figure 6. Box and whisker plots (showing the 5th, 25th, 50th, 75th, and 95th percentiles) of bare soil percentage for upslope contributing areas that did ($n = 77$) and did not ($n = 267$) lead to a breakthrough.

Excluding stream crossing approaches, breakthrough likelihood of occurrence increased with increasing bare soil percentage ($Z=5.2$, $p<0.001$) (Figure 6). Hillslopes with no roads, skid trails, or machine traffic disturbance ($Z=-2.4$, $p=0.02$) or only machine traffic disturbance ($Z=-2.8$, $p=0.004$) decreased the likelihood of a breakthrough. Median bare soil percentage for upslope areas contributing to breakthroughs (40%) was 4 times higher than that of those that did not (10% bare soil).
