Close call when spliced eye on tether cable breaks

Incident

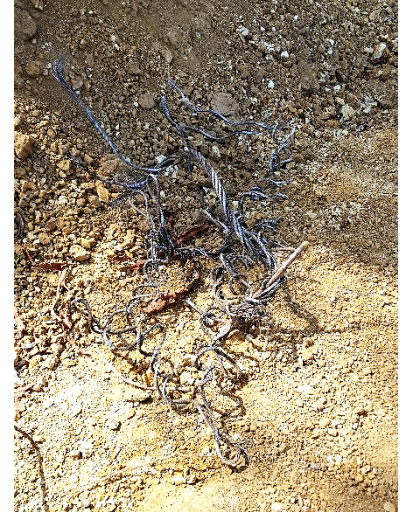
The spliced eye had been inspected that morning and had two broken crown wires, but that is not where the break occurred.

The operator was uninjured, and gained some key safety knowledge through the near miss that his company is now utilizing. The operator stated that the system was safe and it was put back to work that day. Readings from the base machine showed that the line had been over-tensioned 16 times up to 86,000 pounds during the incident. The system is designed at a 3:1 safety factor. The breaking strength of the 1-inch swaged line with a spliced eye is approximately 98,400 pounds, and the recommended maximum tension is 44,000 pounds.

Broken spliced eye

- Inspect all safety features and ensure they are working prior to operation.
- If any safety feature is not operable, stop work until repaired. *After this incident, the manufacturer installed audible alarms that sound if safety systems are not functioning when the machine is started.*
- Install mechanisms that will not allow operation if safety systems are not working properly, or when set safety parameters are exceeded.
- Steep slope machines should have a secondary stopping device.
- Only allow trained, experienced operators to run steep slope machines.
- Place visual safety alarms within operator line of sight.

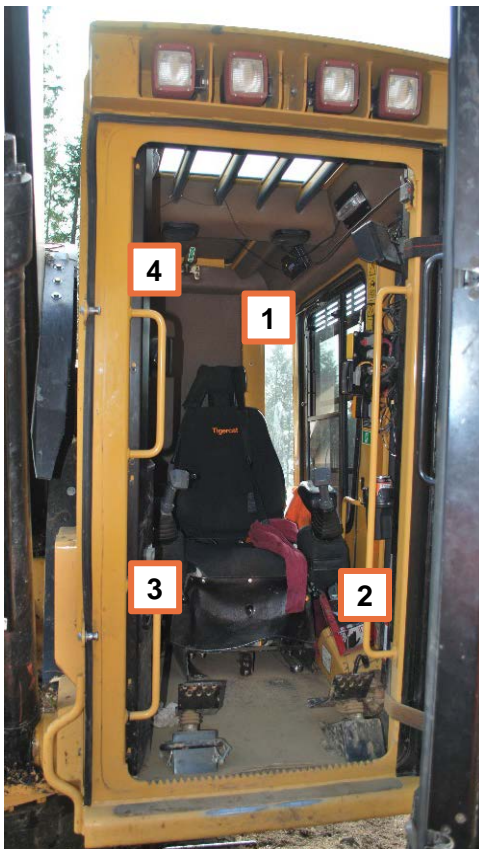
Position of safety features in cab:

The base machine communicates information about cable tension with the SSM through a computer system. The operator receives information about cable tension from a computer screen located on the front wall of the cab on the lower left-hand side. If the system is not working correctly, the tension monitor will read “over tension”, causing the computer screen to flash a warning and an audible alarm to sound. If the signal is lost between the two machines, a light attached to the back wall of the cab behind the operator will change from green to red.

1. Signal sensor (behind operator).
2. Tension monitor screen. During the incident, the screen was flashing a warning, but no audible alarm sounded.
3. Video screen for camera facing up showing trees being felled.
4. Video screen for camera showing base machine drum.
