## Saw Cuts One Line on Dual-line Tether System

### Incident

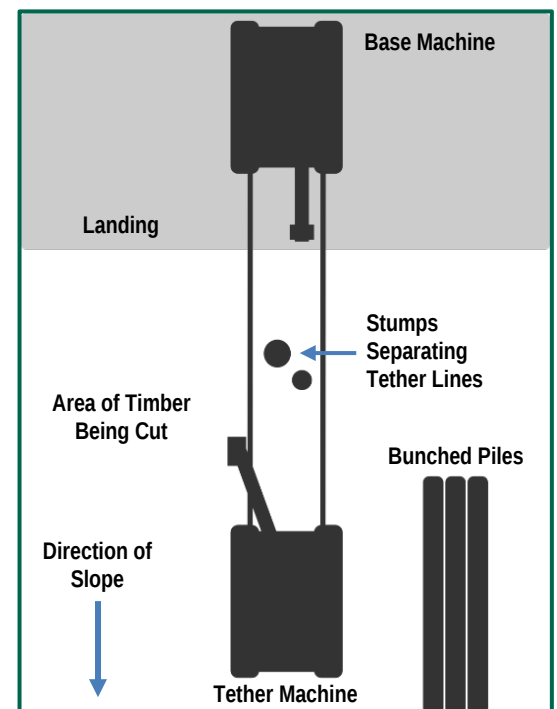
Figure 1. Diagram of dual-line tether system

The base machine had its bucket dug in and tracks parallel to the hill slope on a large landing (Figure 1). Chains connected to the tether machine were shackled to spliced eyes on the lines from the base machine. The lines were in lead with both machines and separated by stumps.

- Ensure the base machine is properly secured.
- Employ a secondary stopping device when using a buncher head.
- Consider using a grapple head or a retractable hot saw on extremely steep slopes.
- Keep lines spaced out by stumps or terrain when using a buncher head.
- Only allow experienced operators to use tethered machines.
- Avoid operating over lines.

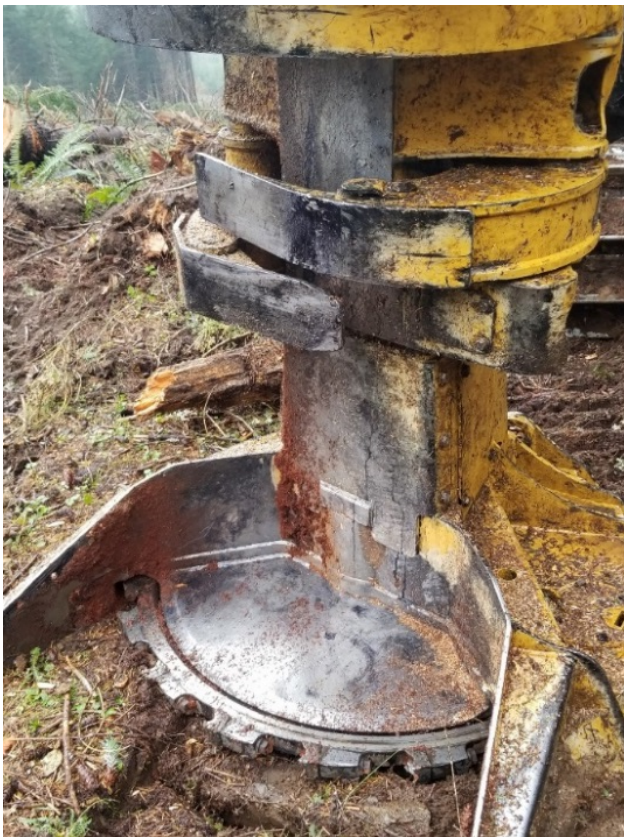
Photo 1. Bunching head used in incident

The operator's reaction was to get the boom grounded immediately. He dropped the tree he had just cut in the standing timber, then began to swing the head around to ground it. In the process, he cut one chain.

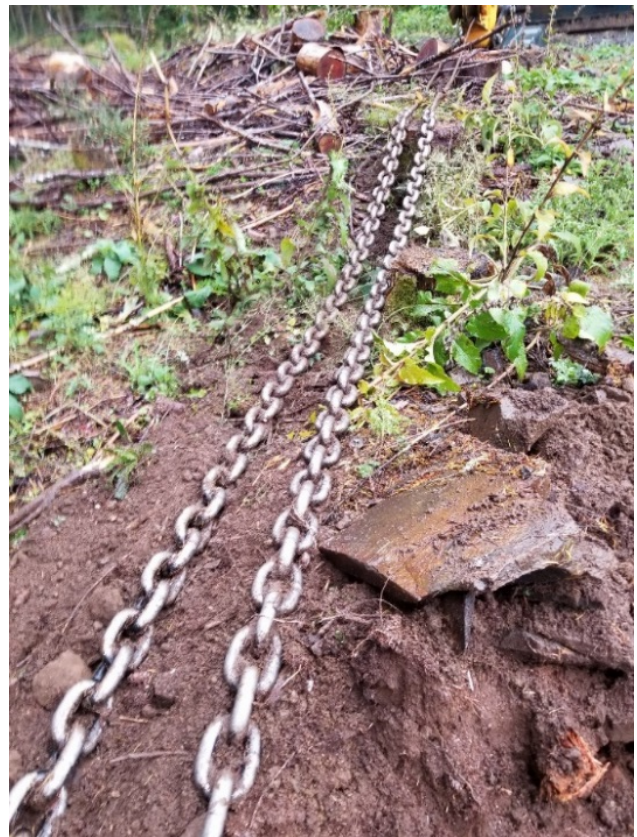
Photo 2. Chains hooked to tether machine

He called the owner and informed them of the situation. The operator replaced the chain he had cut, inspected all components, dug the bucket in better, and began cutting again.
