The productivity and stem breakage impact of fixed felling harvest heads in New Zealand.

Stanley Archibald

FOREST ENGINEERING HONOURS PROJECT 2023
SUPERVISED BY: PROF. RIEN VISSER
NZ SCHOOL OF FORESTRY, CHRISTCHURCH, NEW ZEALAND

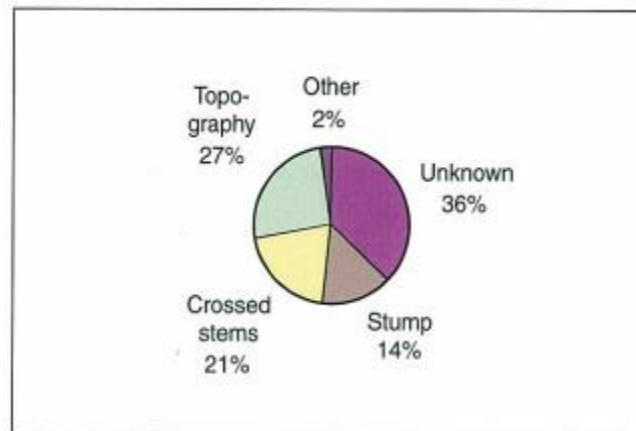
Figure 3 – Distribution of cause of breakage (CBK) (Fraser, Palmer, McConchie, & Evanson, 1997).

As seen in this figure, the main causes were topography and crossed stems, which accounted for the most breakage. However, these two causes are still smaller than the unidentified reasons for tree breakage, where the tree broke for unknown reasons. Of the 1000 stems studied, 314 were unbroken, meaning 68.6% of trees broke. The summarized data showed that smaller trees broke less. The mean tree height and DBH was notably smaller in the unbroken trees. This information is reflected in Figure 4 below.

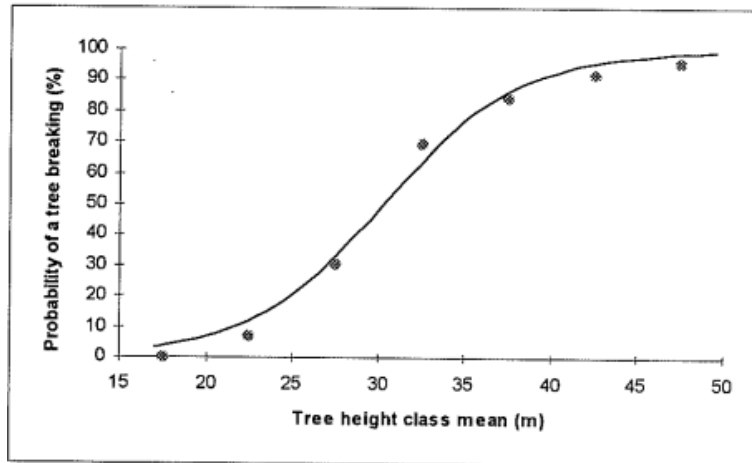
Figure 4: Effect of tree height on tree breaking probability (Fraser, et al, 1997).

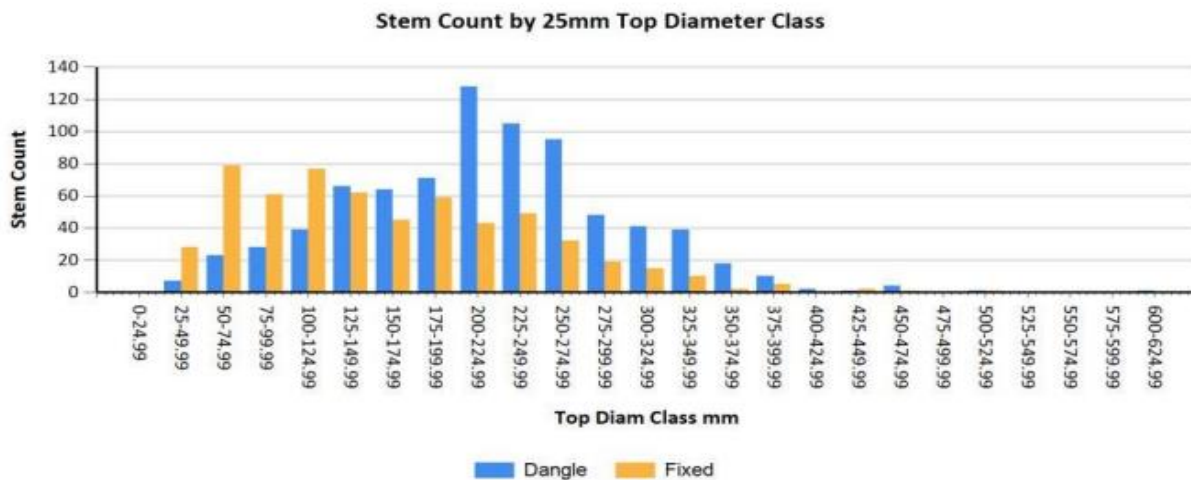
Figure 5: Fixed and dangle STICKS analysis data of small end diameter class comparison (Prebble, 2019).

This data becomes more impressive when knowing that the fixed felling heads trees felled had a larger piece size, the average SED (small end diameter) was still 27% lower than the dangle heads. Average merchantable stem lengths for the dangle head were 16.05m compared to the fixed felling heads 22.5m.

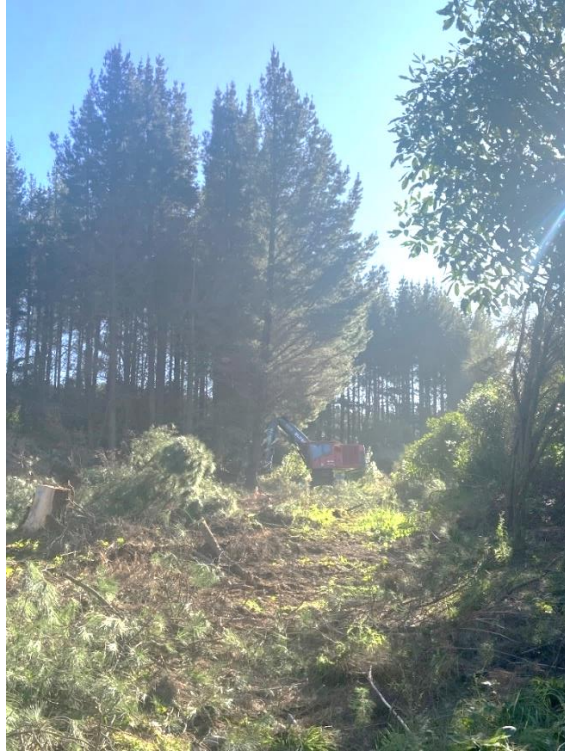
Figure 8: Felling machine operating in action at study site 1.

The operation studied was a road line felling in preparation for roading upgrade and skid installation. The slope was mainly rolling country and predominantly flat, with the slope not going above 9 degrees (~16%). Upon initial inspection, this operation setting meant that a notable number of stems in this study were large with heavy branching, which was a characteristic to keep in mind when recording and later analysing the data. Figure 8 shows the crews felling machine in operation.

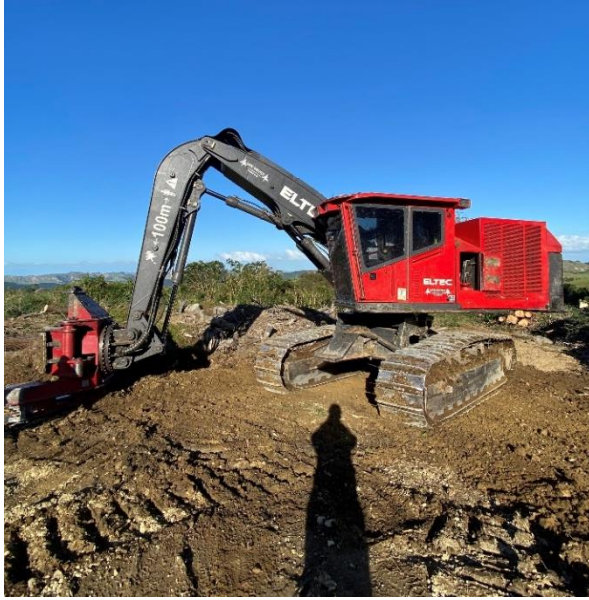
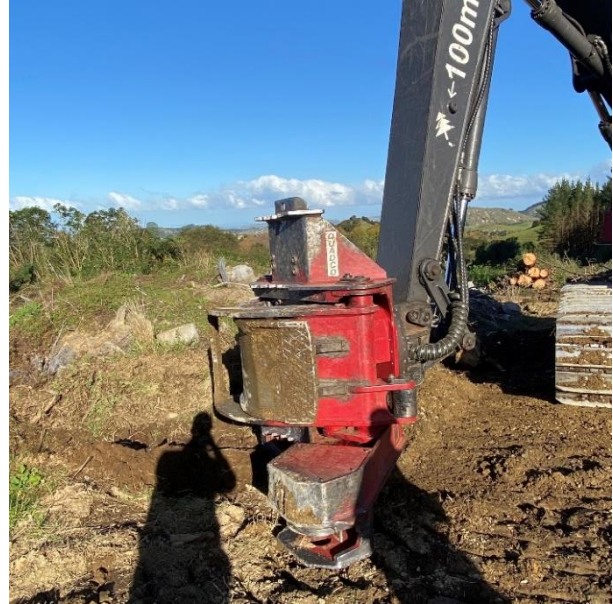
Lew Prince Logging's felling machine was an Eltec 316 base machine with a Quadco QB4400 fixed felling head attached (see figures 9 and 10). The Quadco felling head weighed 3.3 tonnes, with an open-close diameter of 170-1400 millimetres, a 60cc motor and 255 degrees of saw bar rotation. The Eltec 316 base machine weighs around 36 tonnes and has a boom reach length of 7 metres.

Figure 9 and 10: Lew Prince Logging's felling machine (left). Close up of the felling machines Quadco QB4400 felling head (right).

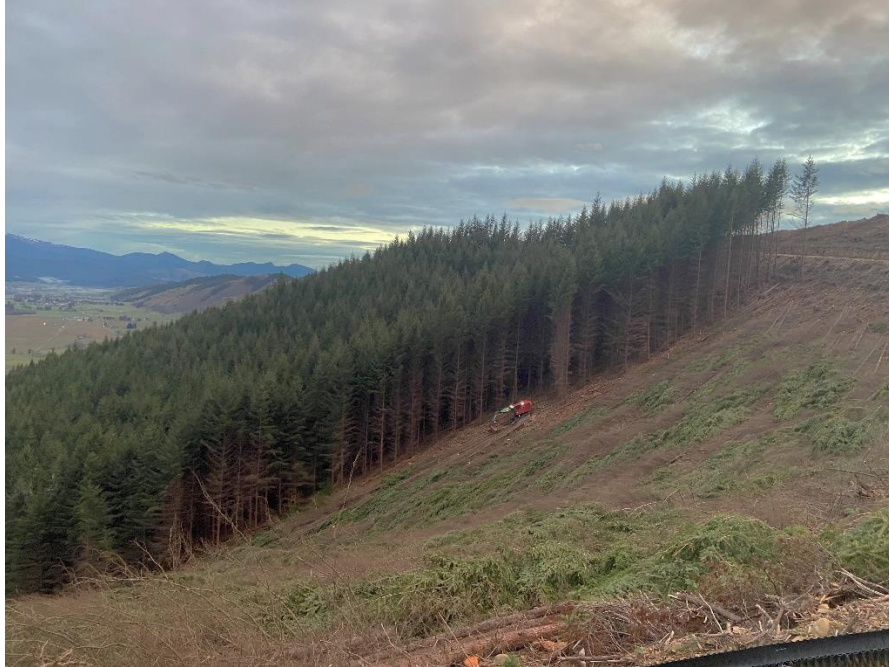
Figure 11: Felling machines main work area where most of its time felling was spent across the study.

The stems studied over two days were situated on a slope with an average grade of 24 degrees (45%). The face was located separately from the rest of the harvesting system as the rest of the crew was still hauling in another gully before they could move to the setting in question. Figure 11 shows the main angle at which the time study was conducted, and the fact that the feller was felling.

What became apparent when discussing with the operator Andy, was that because the yarder would be placed at the top of the hill in the top right of the figure, it was important to ensure the butts of the stems were lying towards the location of the hauler, and that the stems were presented in bunches making extraction faster and more efficient.

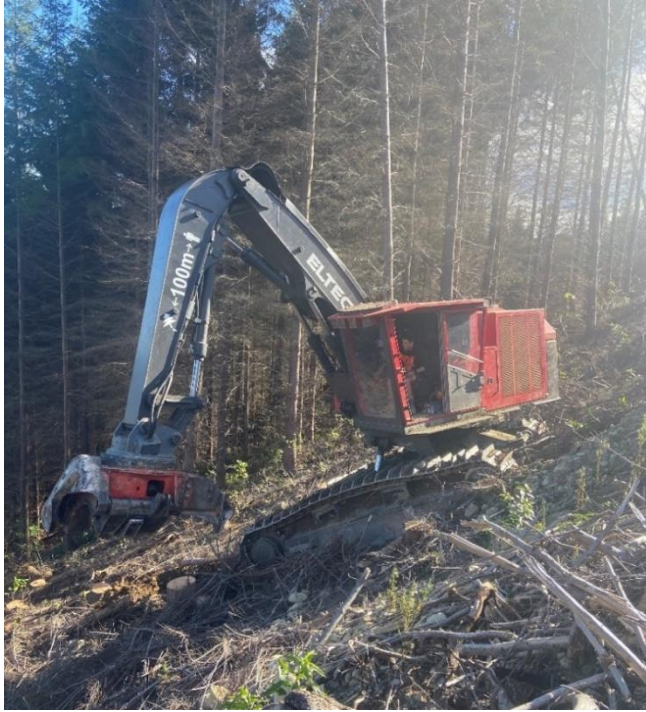
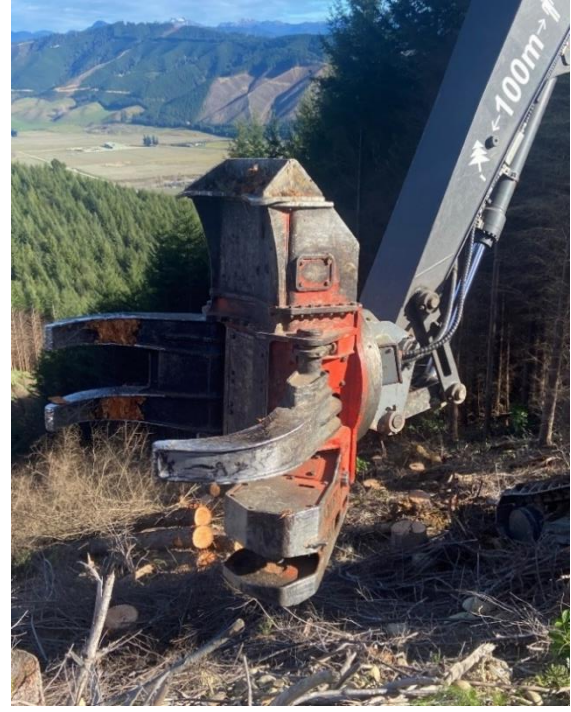
Hightrack Harvesting's felling machine was an Eltec 316 with a Woodsmanpro CFH1400 controlled felling head. The Woodsmanpro weighed 3.2 tonnes, had a 1400mm max cut diameter, 60cc motor, and 243 degrees of saw bar rotation.

Figure 12 and 13: Hightrack's Felling machine (left). Close up photo of the Woodsman CFH1400 Felling head (right).

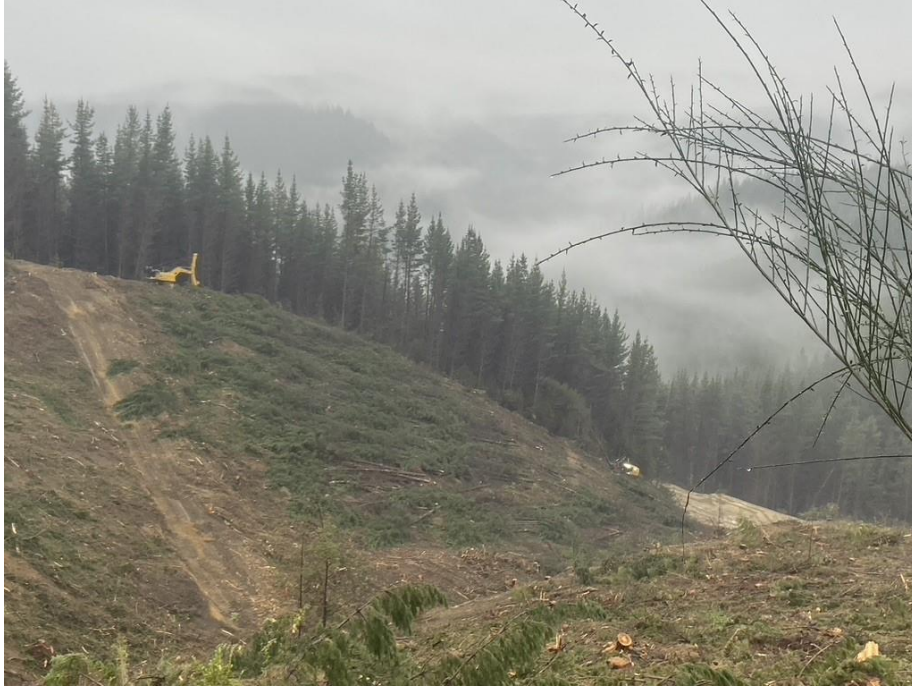
Figure 14: Endurance logging's Felling machine in action at its main work for most of the study.

The crew was situated on a steep slope block with slopes ranging from 30-35 degrees (57-70%). Due to the steepness of the slopes, the crew was opting to perform winch-assisted felling for this forest. Figure 14 shows a wide shot of the felling machine felling, while being tethered to the winch-assist machine, which was the position in which majority of the study was conducted.

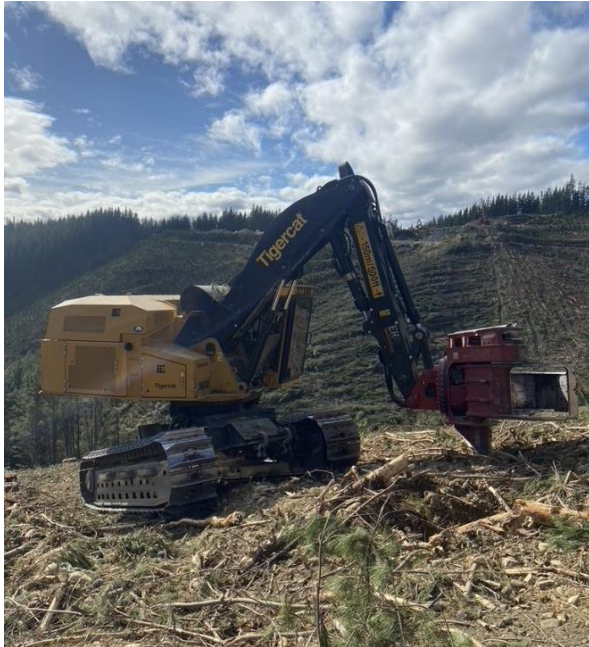
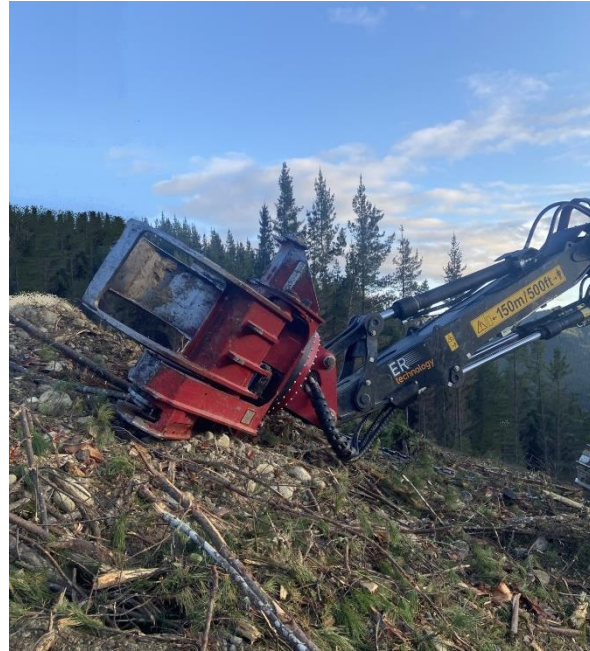
Endurance Logging's felling machine was a Tigercat 855 base with a Quadco 4400QB fixed felling head attached (see figures 15 and 16). The operator of the felling machine Brendan is the owner/operator of the machine as he has part ownership in it. The Tigercat 855 base machine weighs around 30 tonnes and has a boom reach length of 4 metres.

Figure 15 and 16: Endurance Logging/Harmon Harvesting's felling machine (left). Close up photo of the felling machines Quadco 4400QB fixed felling head (right).

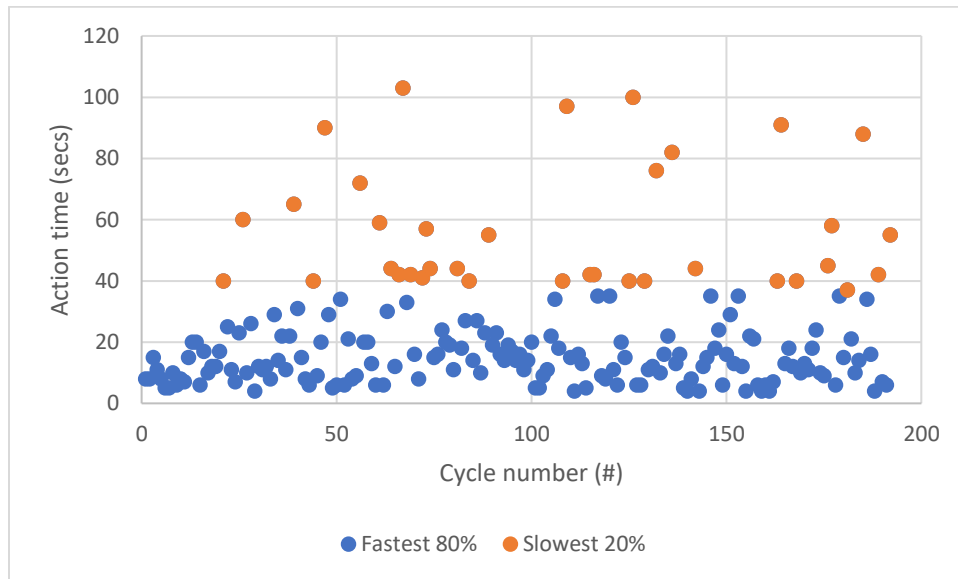
Figure 18: Individual action times for the Walk/Clear action.

As shown in the figure, the majority of the times stuck relatively close to or below the average of 22.4 seconds mentioned in Table 3. However, there are several cycle times that stretch significantly far away from the rest of the times. This is reflected by the standard deviation of this action determined to be 20.0, insinuating a notable amount of variance within the data. The points plotted in orange represent the slowest 20% of action times. These outliers have a notable effect on the average and hold valuable information on what causes this action to take longer. When recording the data, comments were made on the cycle itself and how it went. Figure 19 below shows a summary of what caused those action times to be in the slowest 20%.

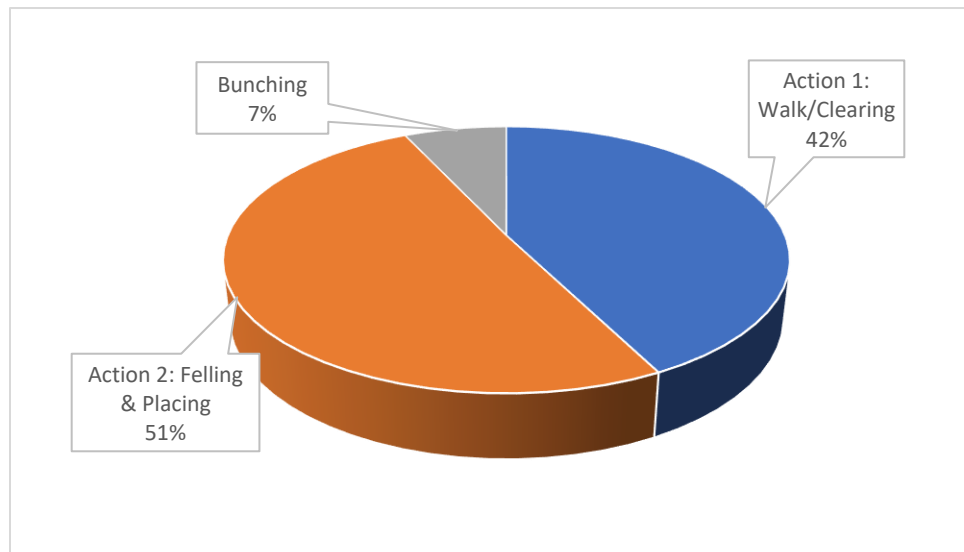
Different from site 1, Fell/Place took longer than Walk/Clear (Table 4). Again, this is further reflected in in Figure 23, which shows the average percentage of time spent completing each action.

Figure 23: Site 2 average time spent completing each action.

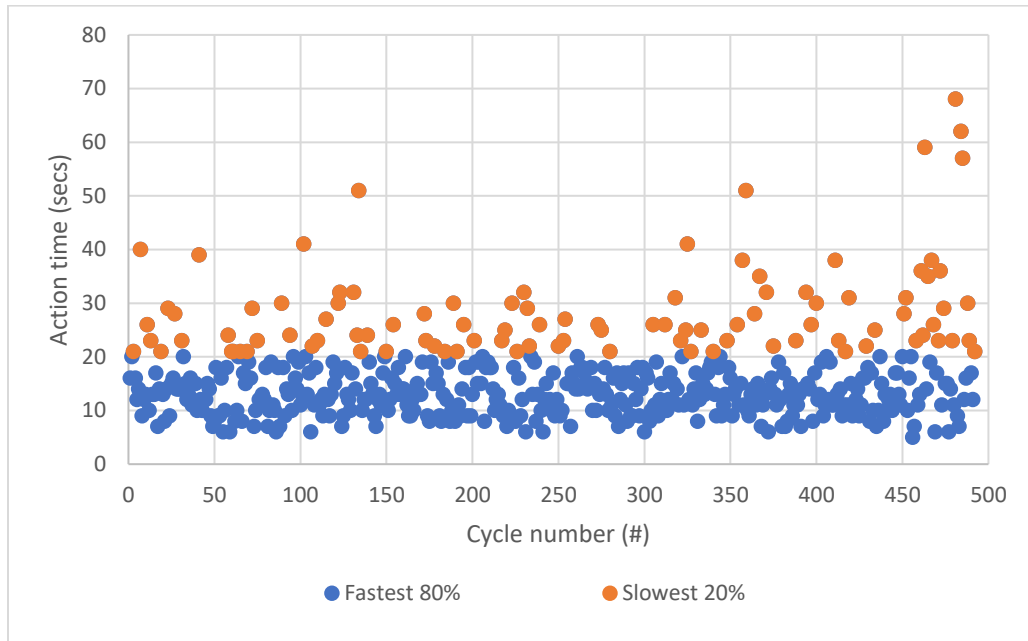
Figure 24: Individual action times for the Walk/Clear action.

As shown above, a tight band of action times is formed around the average action time of 16.1 seconds. The standard deviation for Walk/Clear of this Nelson site was 8.2, reflecting a much more consistent and less variant action time compared to Napier (site 1). Highlighted in orange represents the action times that were the part of the slowest 20%. Here it can clearly be seen that there are a number of significant outliers, as well as minor outliers. Figure 25 shows the causes for those being in the slowest 20% from what was identified while the data collection was occurring.

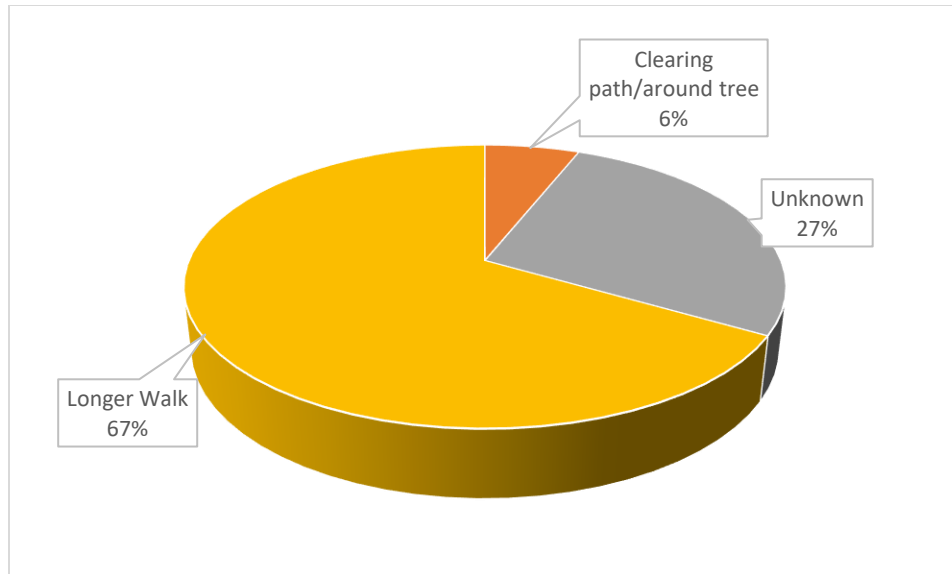
Figure 25: Causes for slowest 20% of Walk/Clear times.

67% of the causes recorded expressed that a longer walk occurred in this cycle, leading to an extended action time. Interestingly only 6% of the causes recorded were due to more extensive clearing to and around the tree unlike site 1's 48%.

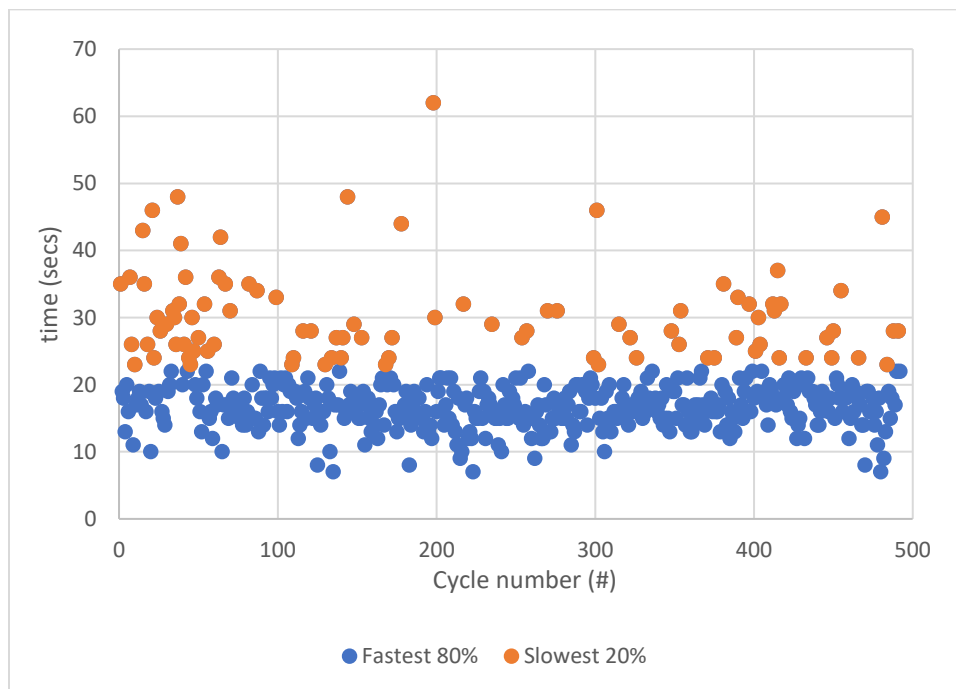
Figure 26: Individual action times for the Fell/Place action.

Figure 26 shows significant clustering around the average action timing of 19.1 seconds, similar to Walk/Clear. This is further reinforced by the lowest standard deviation of 6.7, reflecting notable consistency in the action times. However, there seemed to be more significant outlying recordings in the second action compared to Walk/Clear. These outliers again, are all highlighted in orange displaying the slowest 20% of action times. These times have notable influence over the average time of the action. Figure 27 shows the causes for those Fell/Place times being in the slowest 20%.

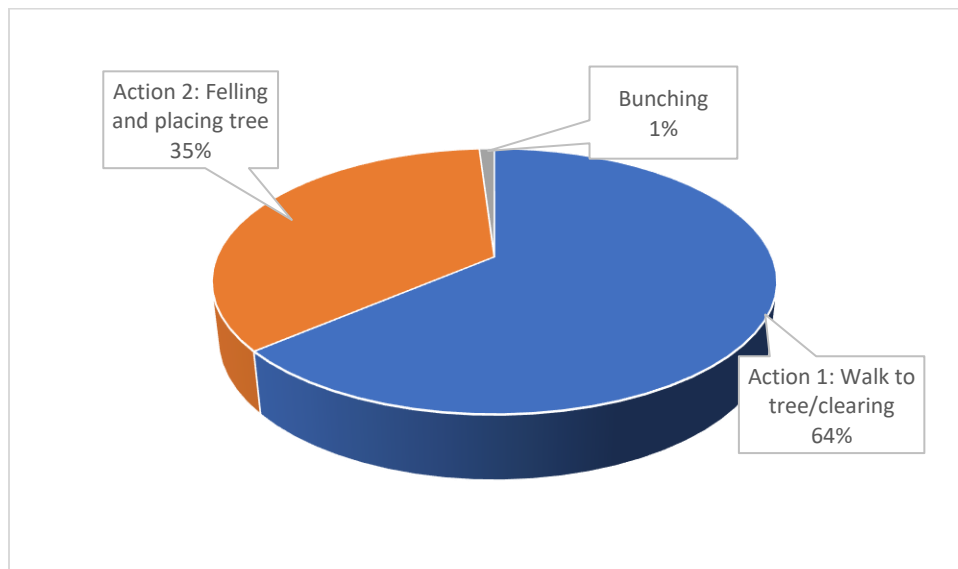
Figure 29: Site 3 average time spent completing each action.

This figure reinforces the difference in average time spent between Walk/Clear, versus Fell/Place, the action of felling and placing the tree in the desired extraction position. Bunching is also seen to again take up a very small percentage of the average time spent. Below shows the cycle times being split into the two actions, where the range and spread of action times can be seen, as well as the ability to analyse the causes for outlying data. Figure 30 shows action times for the Walk/Clear action.

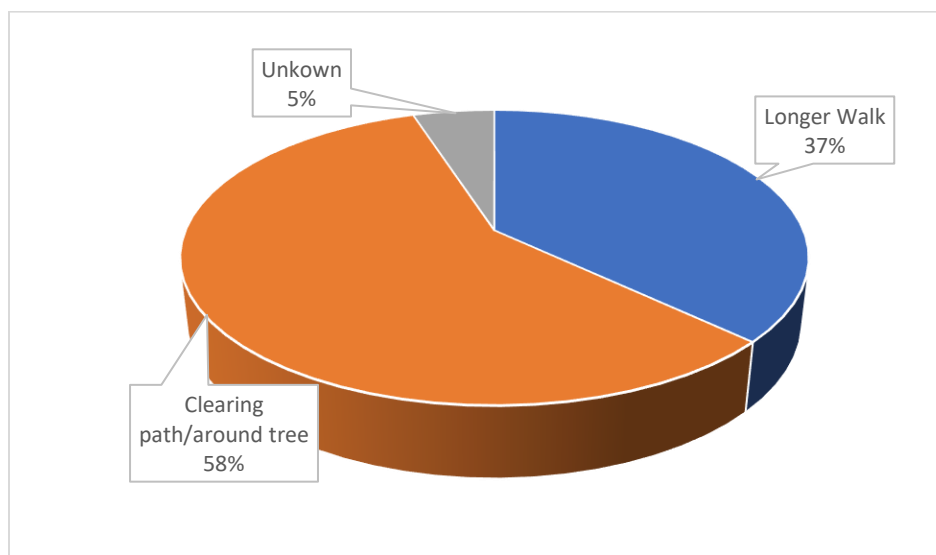
Figure 31: Causes for slowest 20% of Walk/Clear times.

37% of the action times recorded that were in the slowest 20% were said to have been caused by a longer walk time to the next tree, which is much lower than site 2. Most notably, 58% of the action times were longer due to clearing to the tree or around it, amounting to more than half of the causes.

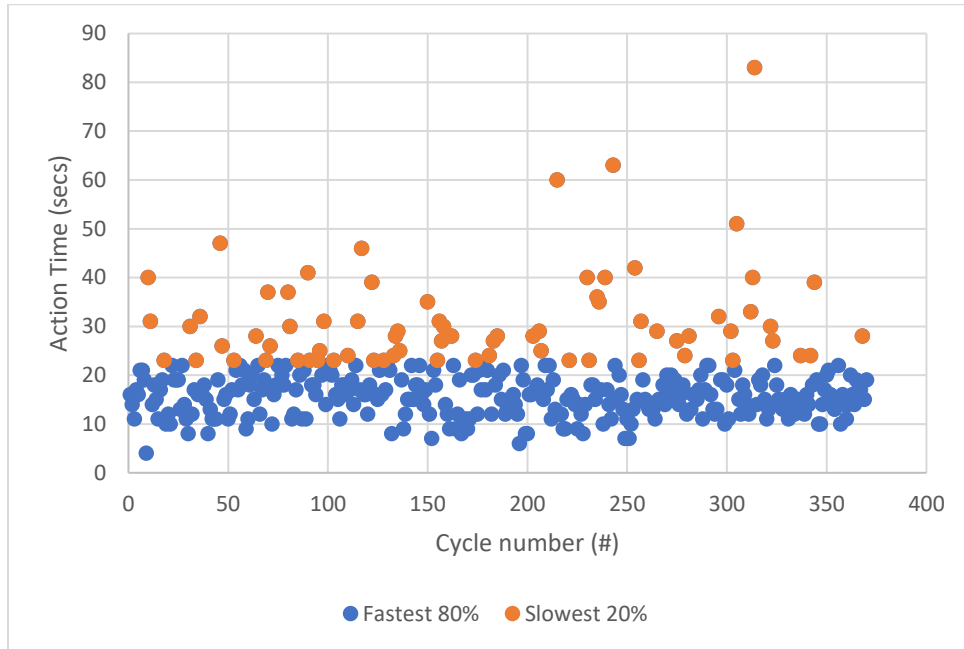
Figure 32: Individual action times for the Fell/Place action.

As from what can clearly be seen in the figure above, a very tight band of data was formed around the average action time of 18.6 seconds. This is further reflected in the standard deviation of the Fell/Place times, which was calculated to be 8.6 seconds, over a third smaller than Walk/Clear's standard deviation. Fell/Place also experienced times that took longer than expected, leading to a number of outliers which can be seen. Again, points marked in orange represent the slowest 20%. To help gain a greater understanding of the causes of this, Figure 33 has been created showing the reasons for those orange Fell/Place times being in the slowest 20%, and what lead to their times being prolonged.

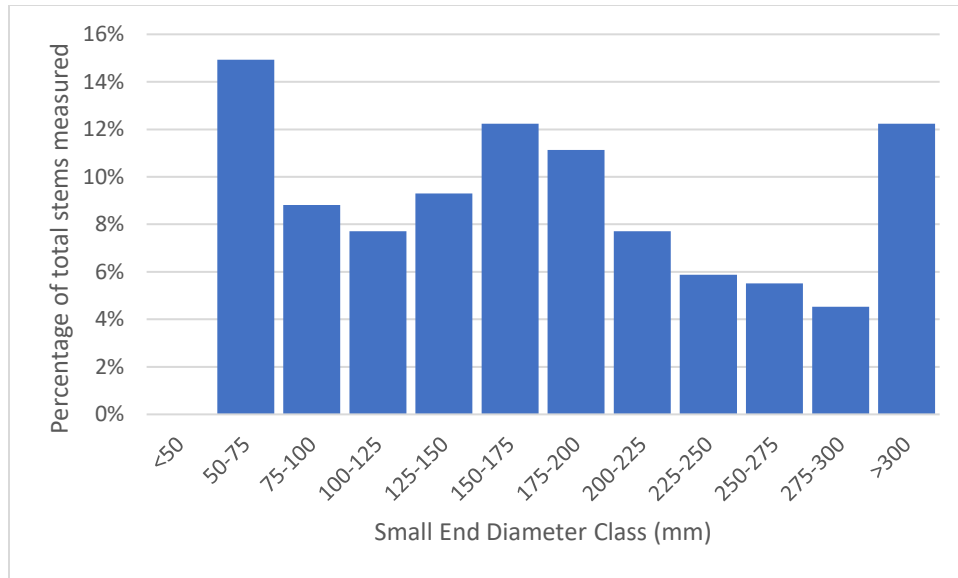
Once the trees recorded in the time study were extracted and processed, the related extraction data was retrieved from the processing machine in the crew. From this data, the small end diameter of the last log cut from each stem was recorded to help gain a better understanding of stem breakage, indicating whether the stem broke or not from the small end diameter measurement. As mentioned before, breakage can also occur during extraction, which needs to be considered. Figure 34 shows the percentage distribution of the SED of the last log cut of each extracted stem.

Figure 34: Site 3 distribution of SED from the top of extracted stems.
