Case study of the state of Fish Passage in a Plantation Forest Estate and the Most Effective Ways to Fix it

University of Canterbury
2018
Georgie Holdaway
Supported by: Nelson Forests Ltd

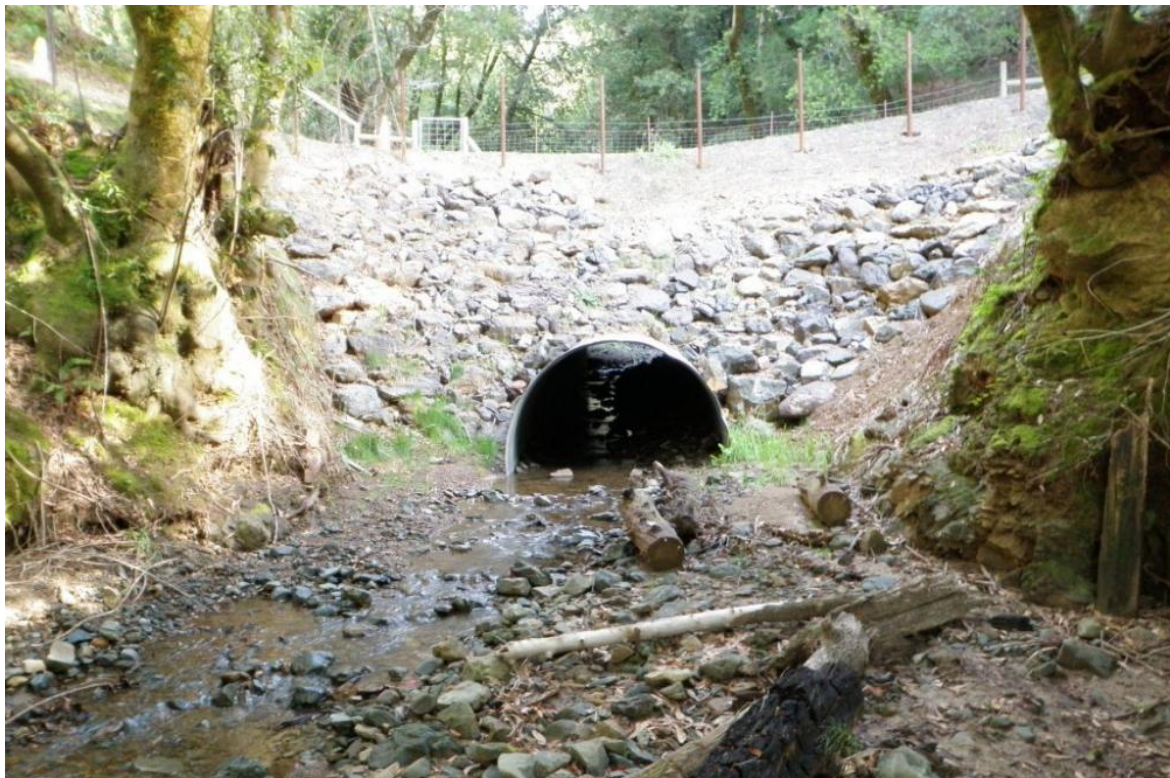
Figure 1- Correctly inverted culvert (Pacific Watershed, 2018)

From the NES-PF, the culvert invert must be located so that at least 20% of the culvert's diameter is below the river bed level. The Guidelines increase this invert/embedment to 25-50% of culvert height, unless the culvert is open bottomed. This increase makes sense as it increases the amount of natural stream bed materials that can congregate in the bottom of the culvert. Natural Stream bed materials aid fish passage by providing rocks and other rough surfaces the fish can grip and/or hide behind while they rest. It also slows the water velocity by roughening the surface it flows over. Figure 1 shows a correctly inverted culvert which has now filled in to provide a natural streambed. This filling process can also be aided by manually setting large material in the pipe, which will help maintain the streambed materials. This is shown in Figure 2.

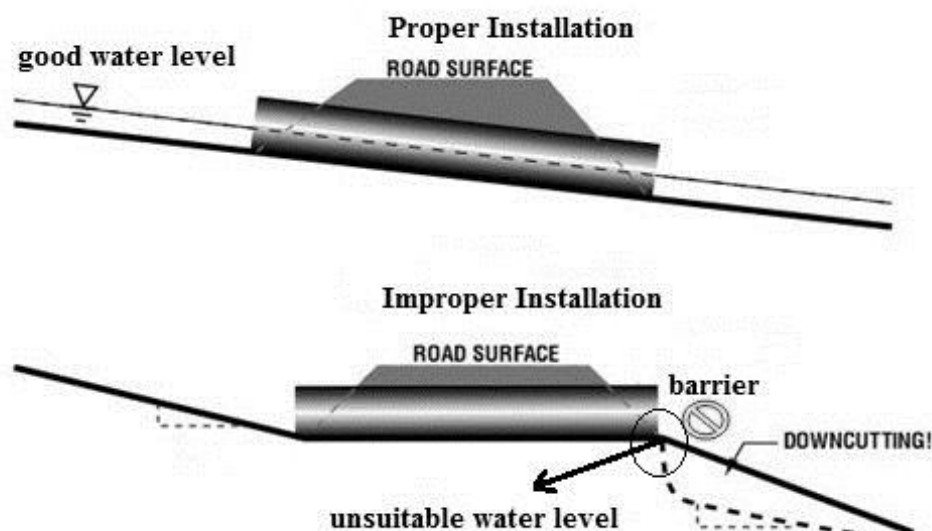
Figure 3- Example of proper culvert installation when considering gradient (Nasiri et.al, 2012)

In more general terms culverts should be installed at a low angle to reduce velocity in the pipe. However, this gradient should be concurrent with the stream gradient either side of the crossing as shown in Figure 3. If this gradient is not kept consistent figure 3 shows it will quickly erode creating a perch.

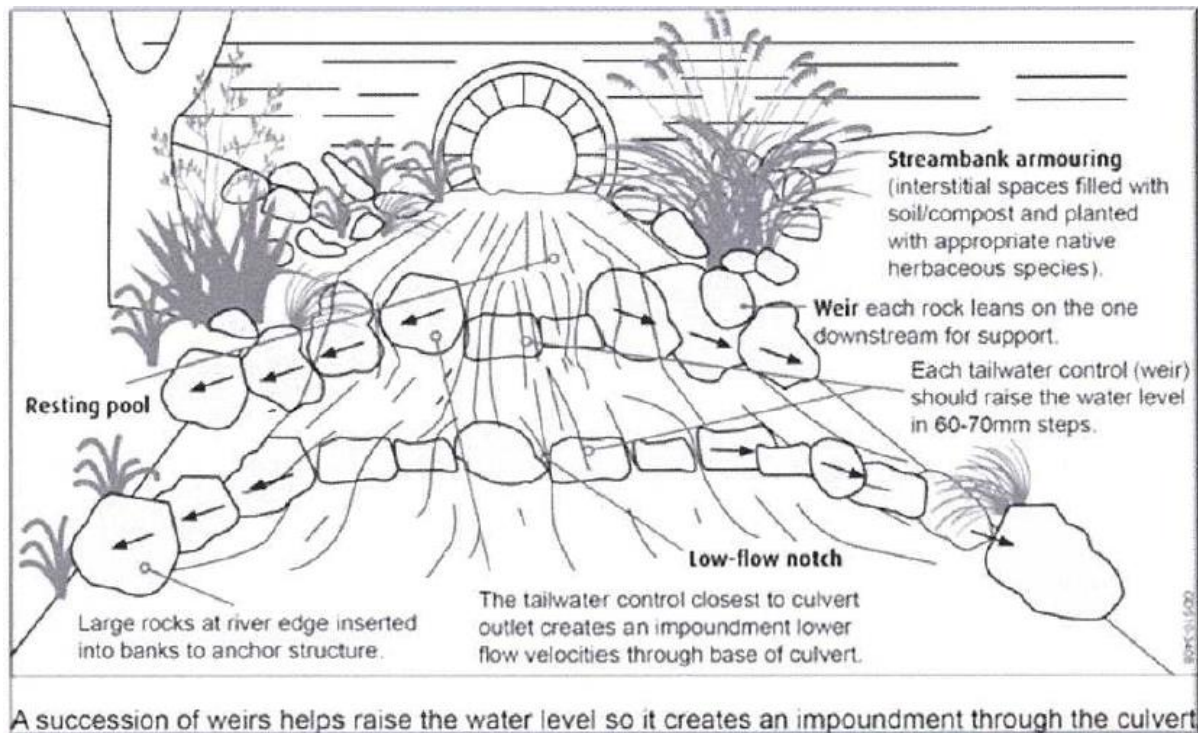
Figure 4- example of rock weir to reduce culvert outlet erosion (Culvert remediation - case studies, 2013)

The broadest specification in the NES-PF for culverts is that the culvert inlet (entry point) and outlet (exit point) must be protected from erosion. A way this can be done is through the installation of a rock weir. These work by decreasing the stream gradient (and therefore

velocity) and introducing a structure that fish can easily ascend. Figure 4 shows an example of how a rock weir can be designed. A rock weir also aids fish passage by slowing velocity in the pipe and providing resting places for the fish before they enter the culvert.

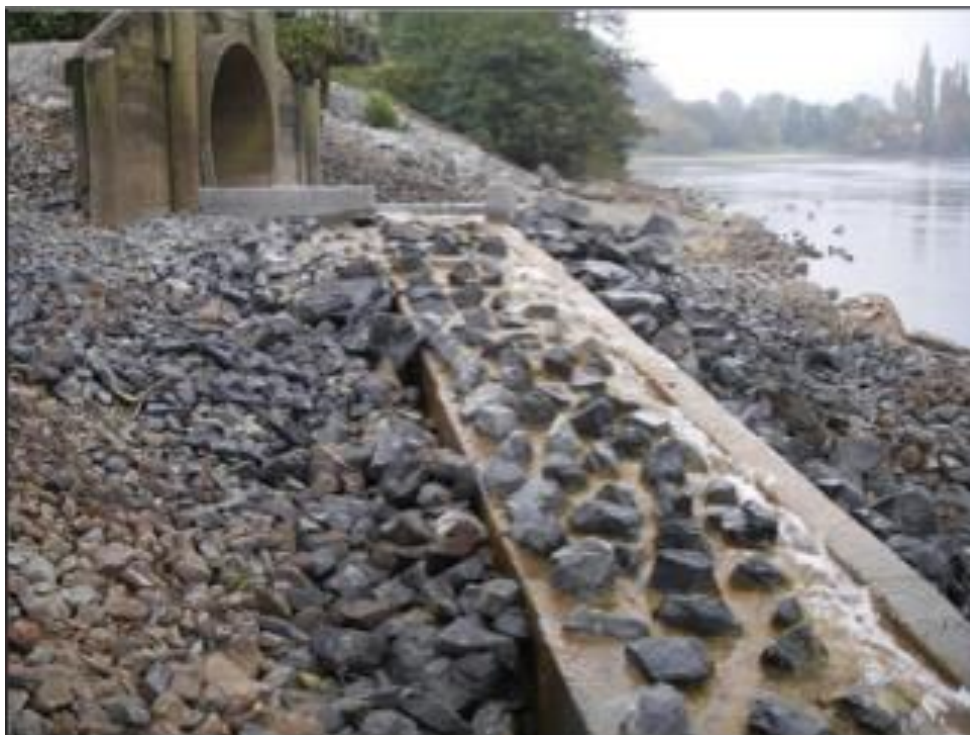
Figure 5- concrete rock ramp (Franklin et al. 2018)

The most common remediation method is the installation of a ramp fishway. They are predominantly used where a perch is present and there is a large vertical drop that fish cannot scale within the system. The guidelines consider a full width rock ramp the optimal design, however, for a forestry environment this solution requires a large amount of materials and labour. Therefore it should only be considered for sites where the perch is especially large. Figure 5 shows a full width rock ramp at low flows. Further design guidelines and recommendations can be found in the New Zealand fish passage guidelines for structures up to 4 meters.

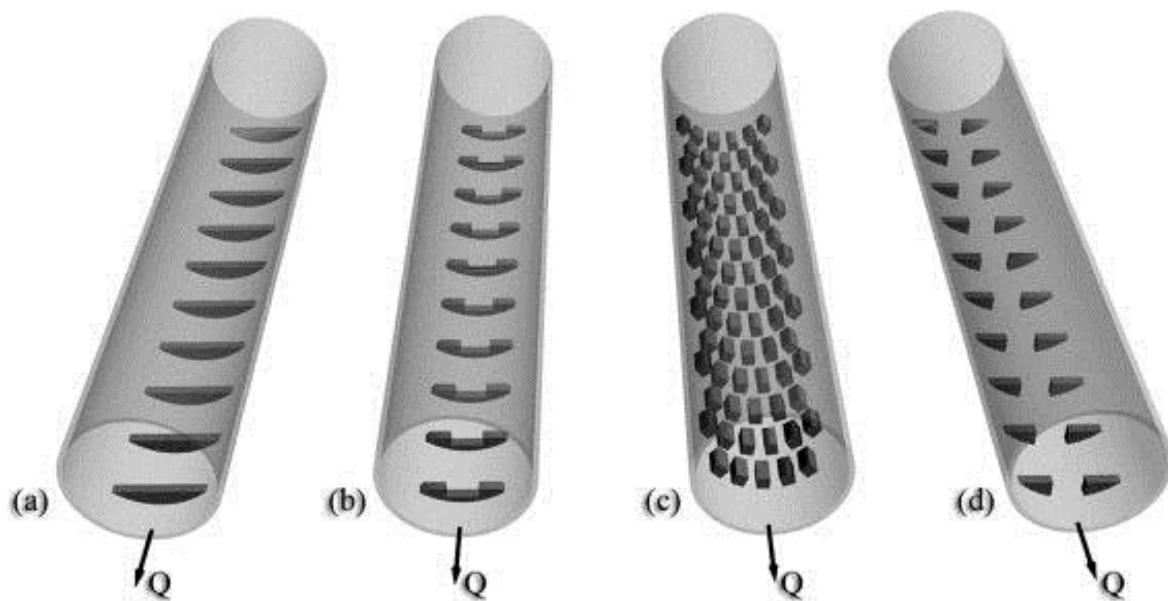
Figure 7- Diagram of different baffle designs (Franklin et al. 2018)

Figure 7 shows 4 baffle designs. Design (a) is a weir baffle and design (b) is an Alberta fish weir. Both these designs work by creating a series of mini weirs which will slow the water. However, weir style baffles are not currently recommended for use where the objective is to optimise fish passage success until further work is done to establish their performance relative to the preferred spoiler baffle designs (Franklin et al. 2018). Design (c) shows the preferred spoiler baffle which is more effective than a weir baffle as fish don't need to be able to climb, they can just weave between the barriers. The slotted weir baffle shown in design (d) slows the flow like a weir of Alberta fish weir baffle, but, leaves a gap for fish to swim through flush with the culvert bottom. This gives it easier fish passage for swimmers than designs (a) and (b).

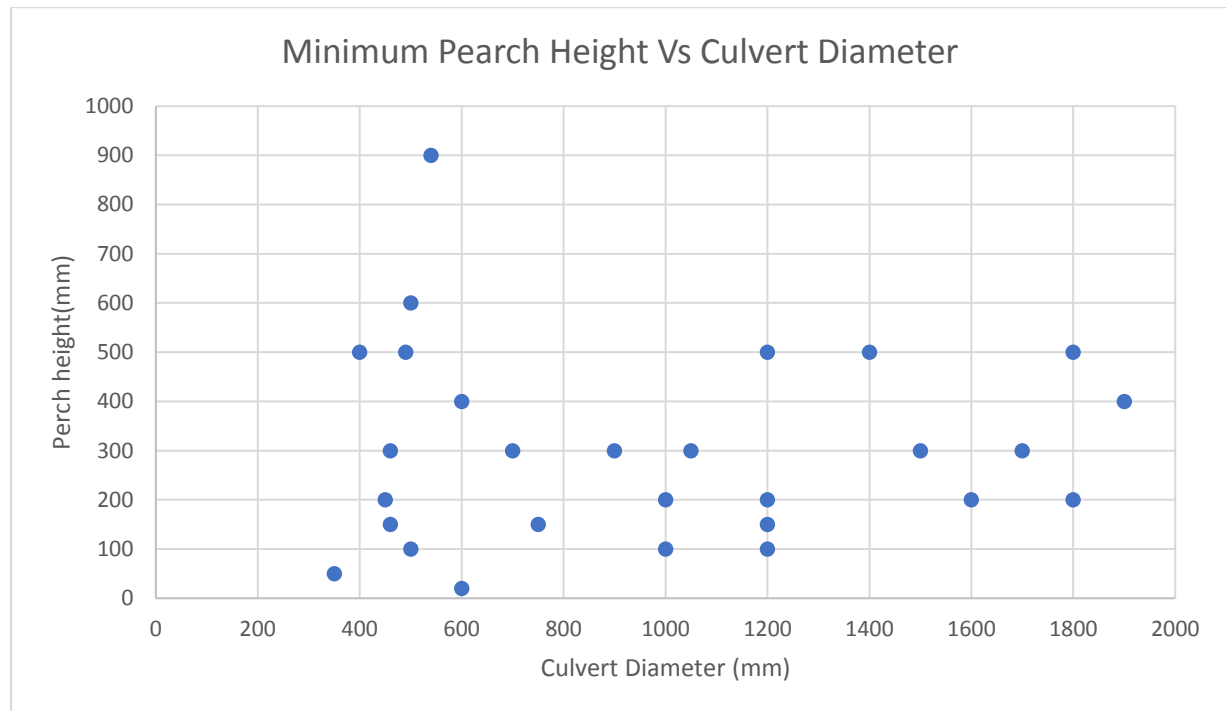
Figure 15- Graph of perch heights and culvert diameters

For the sites which were found to be perched, 28 have had their perch heights recorded. A key cause of missing data was lack of access. For perched sites the average perch height was found to be 300mm. However, there is a clear outlier data point, so excluding the outlier the average perch height was found to be 280mm. Figure 1 clearly shows the outlier point, it also shows there is no clear relationship between culvert diameter and perch height.
