DAMAGED TETHER ROPE

November 2018

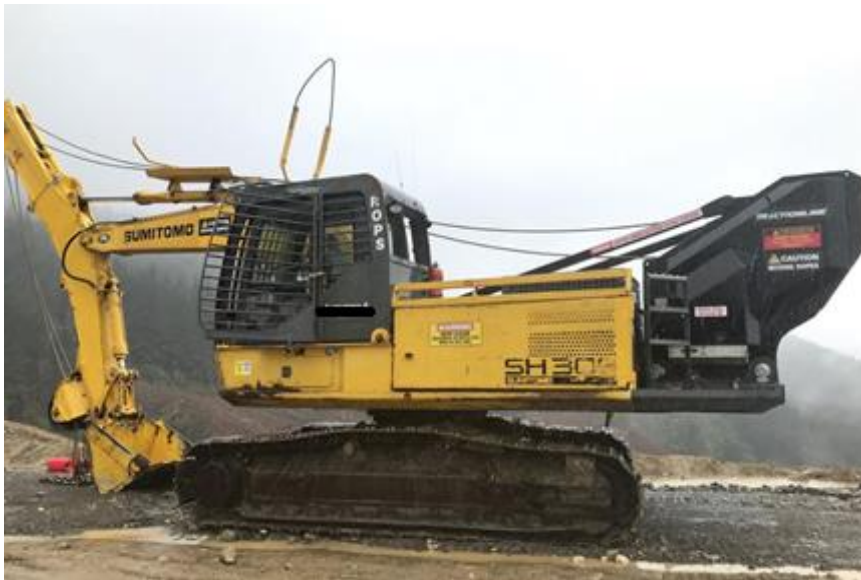
Tether rope was pinched in anchor machine sheave housing resulting in severed strands. Rope required cutting and re-splicing.

Not enough room to bring 909 harvester to the top of the hill so had to reposition anchor to make space. In slewing the tether anchor machine with ropes still attached to felling machine, the ropes got caught on the stumps. The slewing motion coupled with tension on the ropes has resulted in the rope rubbing on the side of the sheave housing.

Pay attention to rope tension out of the sheave and avoid it tensioning at too much of an angle as it can pull the rope up into the fairlead

Fairlead needs to be redesigned or replaced to avoid it happening again (discuss with manufacturer).
