SAFETY ALERT

Broken Tether Rope

Hancock
Forest
Management

9 November 2015

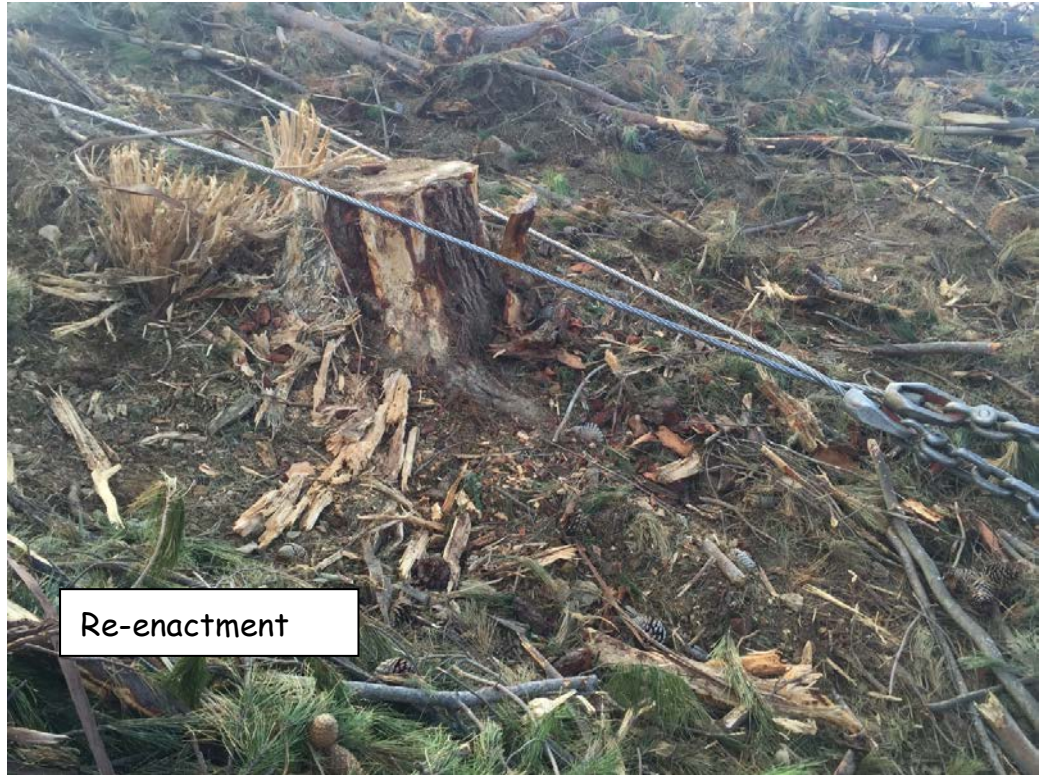
Re-enactment

Unbeknown to the operator the ropes of a twin drum cable-assist machine crossed over one another in front of a stump. The machine began to in-haul and, under tension, one of the winch ropes broke at the ferrule.

The ropes crossed below a tree stump and outside of the operator's line of sight.

The height of the stump was within specification for the terrain.

Crossed over ropes are not unusual and whether the operator had noticed the crossover or not he would have most likely have kept an eye on them but allowed them to correct themselves.

- The rope may have broken from any one or combination of: 1) wear on areas in contact with a sheave; 2) fatigue from repeated bending; 3) mechanical abuse (crushed/cut).

- When an operator observes a crossed over rope they need to pay particular attention to the friction points and ensure they correct themselves promptly and prior to meeting a join (ie at a ferrule).

- Owners and operators must ensure that there are systems to periodically and thoroughly inspect, report, and control wear and damage for all parts of the cable assist system.

- You are especially encouraged to regularly inspect for fatigue or broken wires around termination points (ie ferrules, shackles, etc.).
- All rigging management systems should include clear directions and controls that operators can follow when inspecting rigging ie discard when three or more broken wires are found in close proximity of a termination point.

- Record all broken wires in a daily rigging examination workbook.

- If at any time a change in the rope condition is suspected it should be reported immediately and the equipment taken out of service until the rope has been examined by a competent person.
- The fact that neither machine broke free, slid or rolled re-affirms that the system was working optimally. It was within its safe working window and assisting, not guaranteeing, the stability of the harvesting and extraction operation.
