This incident occurred in Marlborough with a woodlot crew. The operator was in the machine shovelling non-cable assist. The slope was about 30 degrees.

This Event occurred mid-July 2019

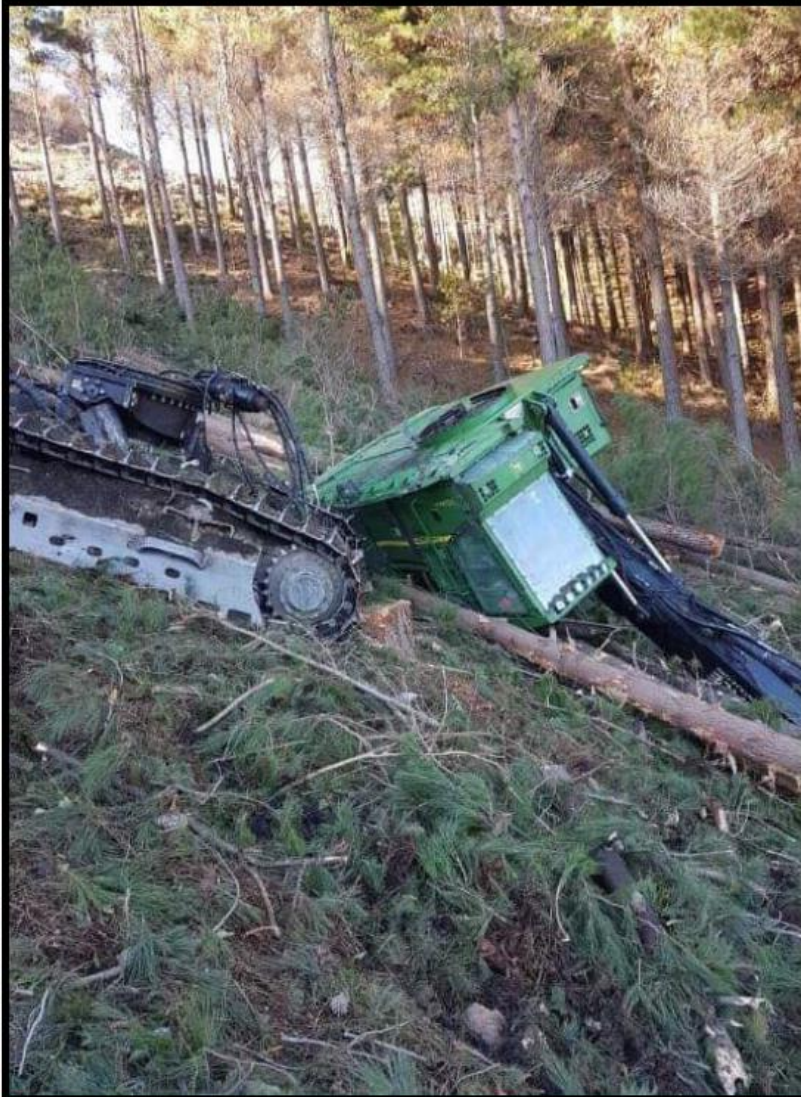
- Because the operator was wearing a seatbelt and in a proper built cab he was not injured.
- During cable assist operations the machine swivel/ring takes a large amount of stress and strain as the machine is very stable on the tracks but the machine is taking a lot of weight on the boom and cab.
- Most contractors I talked to have daily check for cracks and broken or loose bolts on the swivel.
- Machines inspections are finding cracks that require welding to repair on a regular frequency.

Please take the time to inspect and ensure your machines are maintained in a safe condition.
